TREE EMERGENCY INSPECTION REPORT

TREE NO	T17	REF NO	005
INSPECTION NO	E03	INSPECTION DATE	23 Jan 2010 24 Jan 2010
OWNER	Maryknoll Convent School	ACTUAL LOCATION	114° 10' 43" E 22° 19' 40" N
GEOGRAPHICAL LOCATION	Northwest Corner of the Building of Maryknoll Convent School, No. 130 Boundary Street, Kowloon.	WEATHER CONDITION	Fine

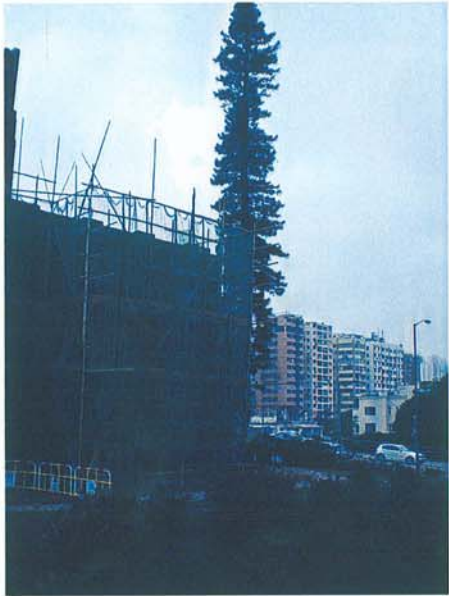
<p>Fig 1: Tree overall looking on Jan 24.</p>

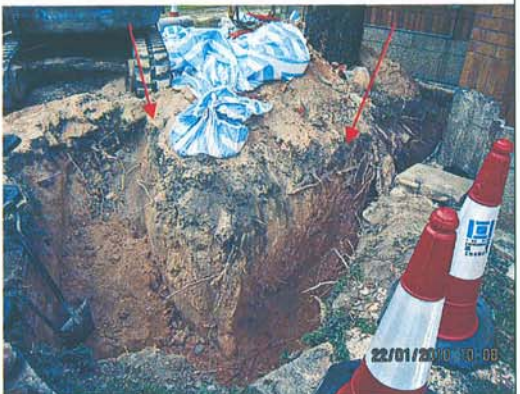
SITE	<p>1. Two deep trenches 400 mm (wide) x 800 mm (deep) were dug on two sides of the tree by the Construction Contractor.</p> <p>2. The distances between the trenches and the base of the main trunk of the tree were less than 1 meter.</p> <p>3. Two major side roots 100 mm (dia) was exposed and badly damaged, much of small roots was find by cutting.</p> <p>4. QA was identifying the fungicide to protect the damage root surface asap.</p> <p>5. The Construction Contractor backfill the soil on Jan 24 noon.</p>
GROUND COVER	The ground vegetation cover surrounding the tree was completely ruined by machinery movement. The soil was also compacted by the movement of the machinery and the weight of the machinery plus the concrete mixed carried.

ORIGIN OF RISK	Due to the Construction Contractor digging the trench very closed to trunk, and damage tree roots system.		
HAZARD RATING	<p>Hazard Rating = Failure Potential + Size of Part + Target Rating</p> <p style="text-align: center;">11 = 3 + 4 + 4</p> <p>Hazard Location: <u>Roots</u></p>	<p>Failure potential: 1 = low; 2 = medium; 3 = high; 4 = severe</p> <p>Size of part: 1 = <50mm; 2 = 51 – 100mm; 3 = 101-150mm; 4 = >150mm</p> <p>Target rating: 1 = occasional use; 2 = intermittent use; 3 = frequent use; 4 = constant use</p>	
RISK RATIO	Due to 50% surface root system was damage, surface soil was compact by heavy machine, tree dead ratio more than 50%.

<p>Fig 2: Two trenches were digging up on Jan 23 that closed to tree trunk.</p>
-----------------	---	--

HAZARD ABATEMENT	<p>1. Restrict Area : 1</p> <p>2. Cable : 0</p> <p>3. Removal : 0</p> <p>4. Replanting : 0</p> <p>5. Prune : 0</p> <p>6. Supporting : 1</p> <p>7. Effect on adjacent tree : 0</p> <p>8. Inspect further : 0</p> <p>9. Notification : 0</p> <p>This kind of work defied the purposes of protecting the respective tree.</p>	<p>CARRY OUT THE WORK :</p> <p>0=NONE;</p> <p>1=IMMEDIATELY;</p> <p>2=STAY BEHIND;</p> <p>3=UNNECESSARY;</p> <p>4=OTHER_____</p>
COMMENT	<p>1. The tree unstable now, tree supporting system immediate needs.</p> <p>2. Inspection by weekly.</p>
