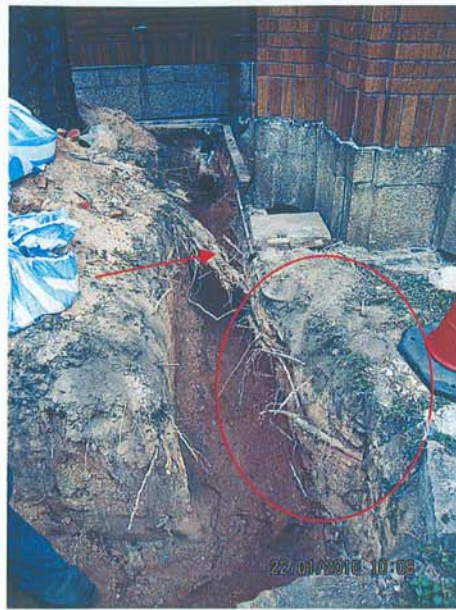
Fig 3: The root system was damage, record on Jan 23.

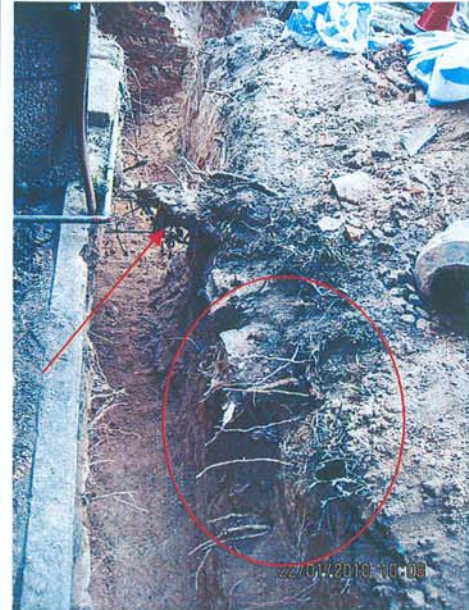
Fig 4: The root system was damage, record on Jan 23.

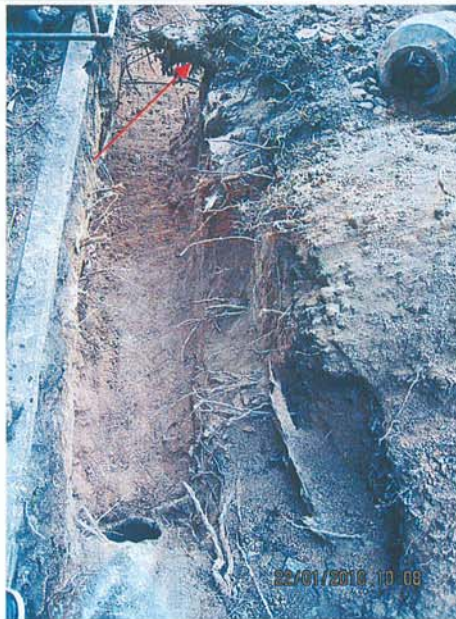
Fig 5: The root system was damage, record on Jan 23.

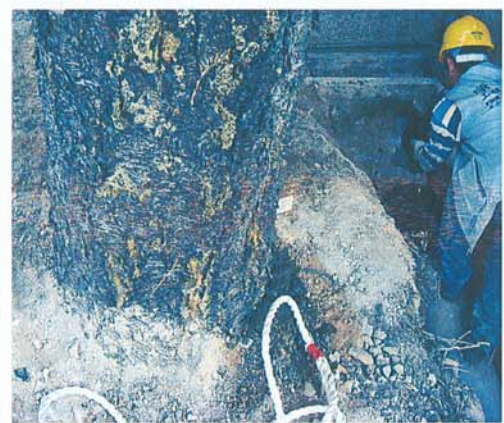
Fig 6: The truck and trench, record on Jan 23.

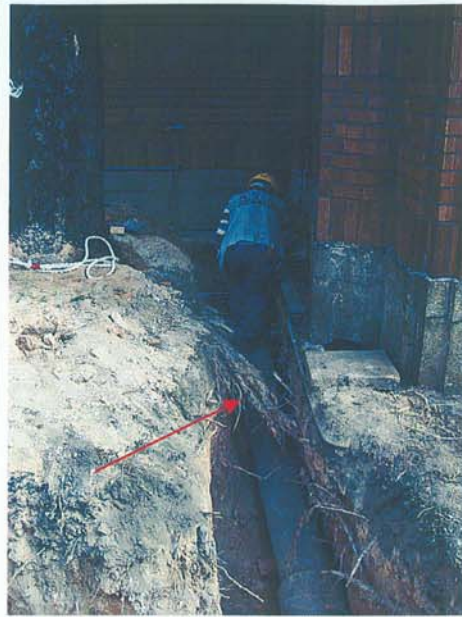
Fig 7: The truck and trench, record on Jan 23.

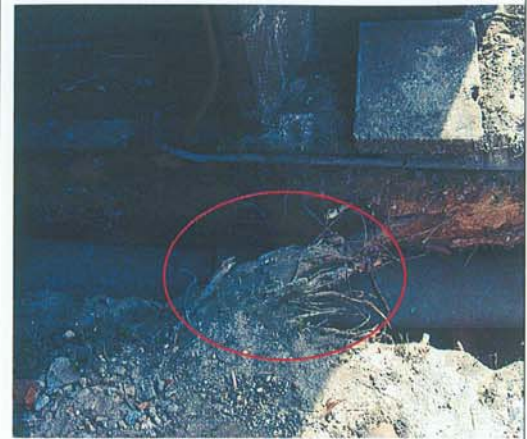
Fig 8: The truck and trench, record on Jan 23.

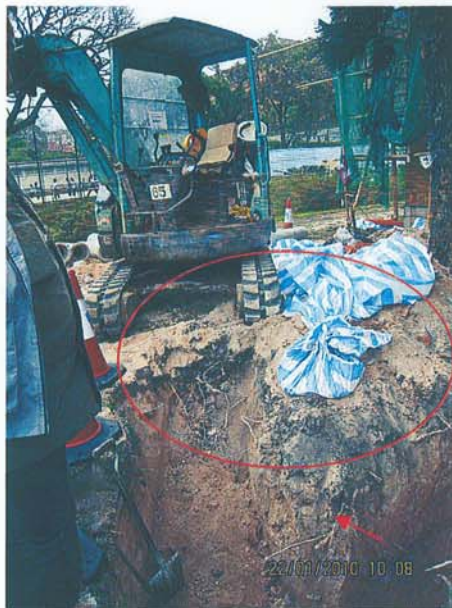
Fig 9. Heavy duty machine on surface, record on Jan 23.

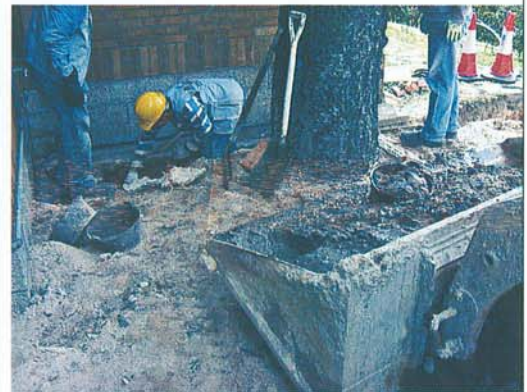
Fig 10. Bobcat and concrete near trunk, record on Jan 23.

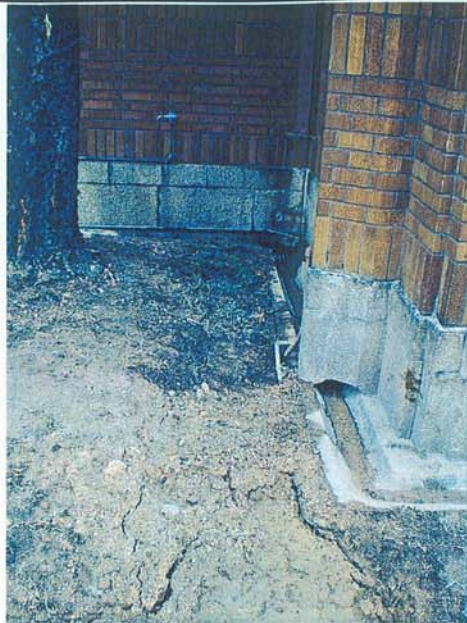
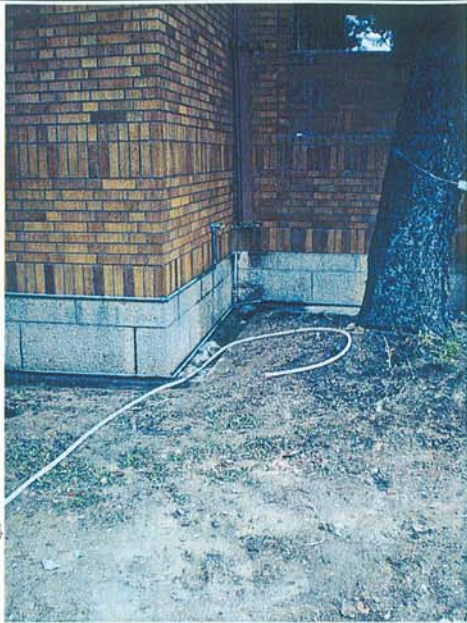
| | <p>Fig 11. Trench backfill soil, record on Jan 24.</p> | <p>Fig 12. Trench backfill soil, record on Jan 24.</p> | |

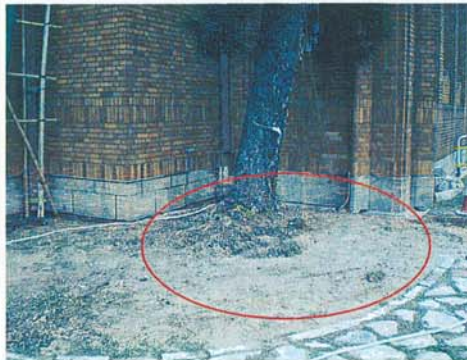
| | <p>Fig 13. The surface ground cover was badly mangled, record on Jan 24.</p> | | |
