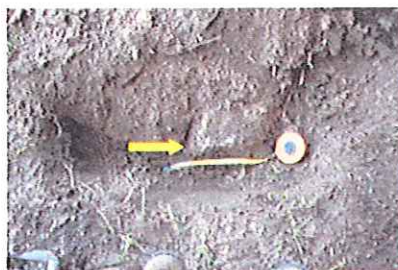
Root pruning: AG excavated Trench 1, which is the primary trench located along the southern side of the tree, to measure the number and size of roots cut during trenching. AG found a large number of small roots severed along the entire length of Trench 1. AG also found and measured a large root 80 cm from the root collar. This root measured 160 mm diameter at the cut. The loss of these small and large roots reduces the structural stability of the tree. Research has indicated that small roots near the surface, as was observed in this instance, provide significant structural support and removal of these roots may result in loss of structural support greater than 20%.¹ These roots, including the large root that was severed on the southern side of the tree, are primarily located in transverse orientation to the tree lean, which reduces its importance in terms of structural support to off-set the lean. However, these roots provide significant support during strong southerly winds. Given the size, location and development of the large root that was cut, it likely provided significant support during strong southerly winds.

Large Root Severed (arrow). Smaller, cut roots can be seen throughout excavation

1. Cable the tree to a structure or the ground. Two cables, constructed of steel materials, attached to the trunk and then to a structure or anchored in the ground, could provide adequate support comparable or exceeding the pre-trenching condition. The cables should be aligned to provide support of the tree from the northeastern and southeastern quadrants. The type and size of cable and cable attachments must be engineered to effectively support the load of the tree. The cable must be attached 2/3 up the height of the tree, which is approximately 16 meters, and affixed so that the cable is a 45° to 90° angle to the lower trunk. AG understands that the structures and topography present significant challenges to this solution and would require engineering expertise that is beyond the scope of AG's expertise.

2. Should cabling prove impractical and tree preservation is desired, it is recommended to reduce the crown height of this tree by approximately 20%. AG believes that topping is the only other practical option that will preserve the tree and significantly reduce structural stress on the damaged root system, reduce target exposure and reasonably reduce risk of whole tree failure. Crown reduction will not eliminate the risk of whole tree failure. Removal of a significant section of the crown top results in the significant reduction of the weight of the wood mass, moisture weight load from precipitation, and structural stress from wind loads. Crown reduction also reduces the number of targets exposed by making the tree smaller. The actual amount of risk reduction depends upon the amount of the top removed. AG recommends approximately 20% reduction in an effort to reduce risk of failure while minimizing the potential impact on tree health. It is impractical to accurately quantify the precise reduction of risk from this crown reduction. However, AG's extensive experience and understanding of biomechanical engineering, and industry research has clearly demonstrated that proper crown reduction reduces the risk of failure.

3. Felling, also referred to as tree removal, is recommended if cabling or topping are determined to be impractical or undesirable. AG believes that if cabling or topping are not conducted, that this tree poses an unreasonable risk to public safety at this time and should be felled.

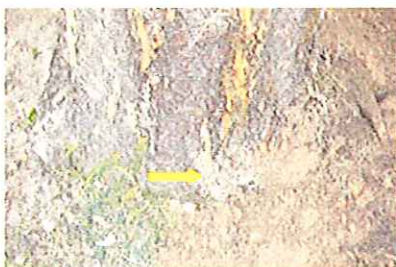
Cracks/seam: A seam in the bark at the root collar was observed on the west side of the tree. This seam extends high up along the trunk. This seam, which appears to be an old stress crack area, has compartmentalized and currently tests as sound.

Root Collar Seam

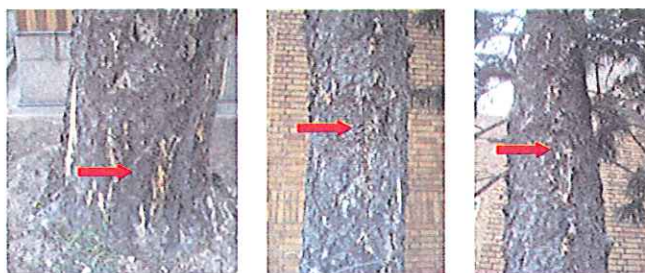
Cracks/seam: Seams in the trunk were observed on the west and east sides of the tree. The seam on the west side initiated at the root collar and extended up the trunk, vertically to a point approximately 8 meters high. This seam was not continuous, but was only interrupted for short distances along the trunk. Signs of historic sap flow were observed emanating from this seam. Woundwood that closed the seam was observed along the entire seam. This seam, which appears to be an old stress crack area, has compartmentalized and currently appears sound. Resistograph measurements at several points along the seam found no decay, cavities or deep cracks associated with these seams.

Low Trunk ~ 3 meters high ~ 5 meters high
Trunk Seam West Side of Tree

Trunk Seam East Side of Tree
