Accident Bulletin 1/2011

(An update Bulletin to Accident Bulletins 1/2010 and 3/2010)

**Update on Investigation of
Aircraft Accident on CPA 780 on 13 April 2010
(Airbus A330-342 Registration Mark B-HLL)**

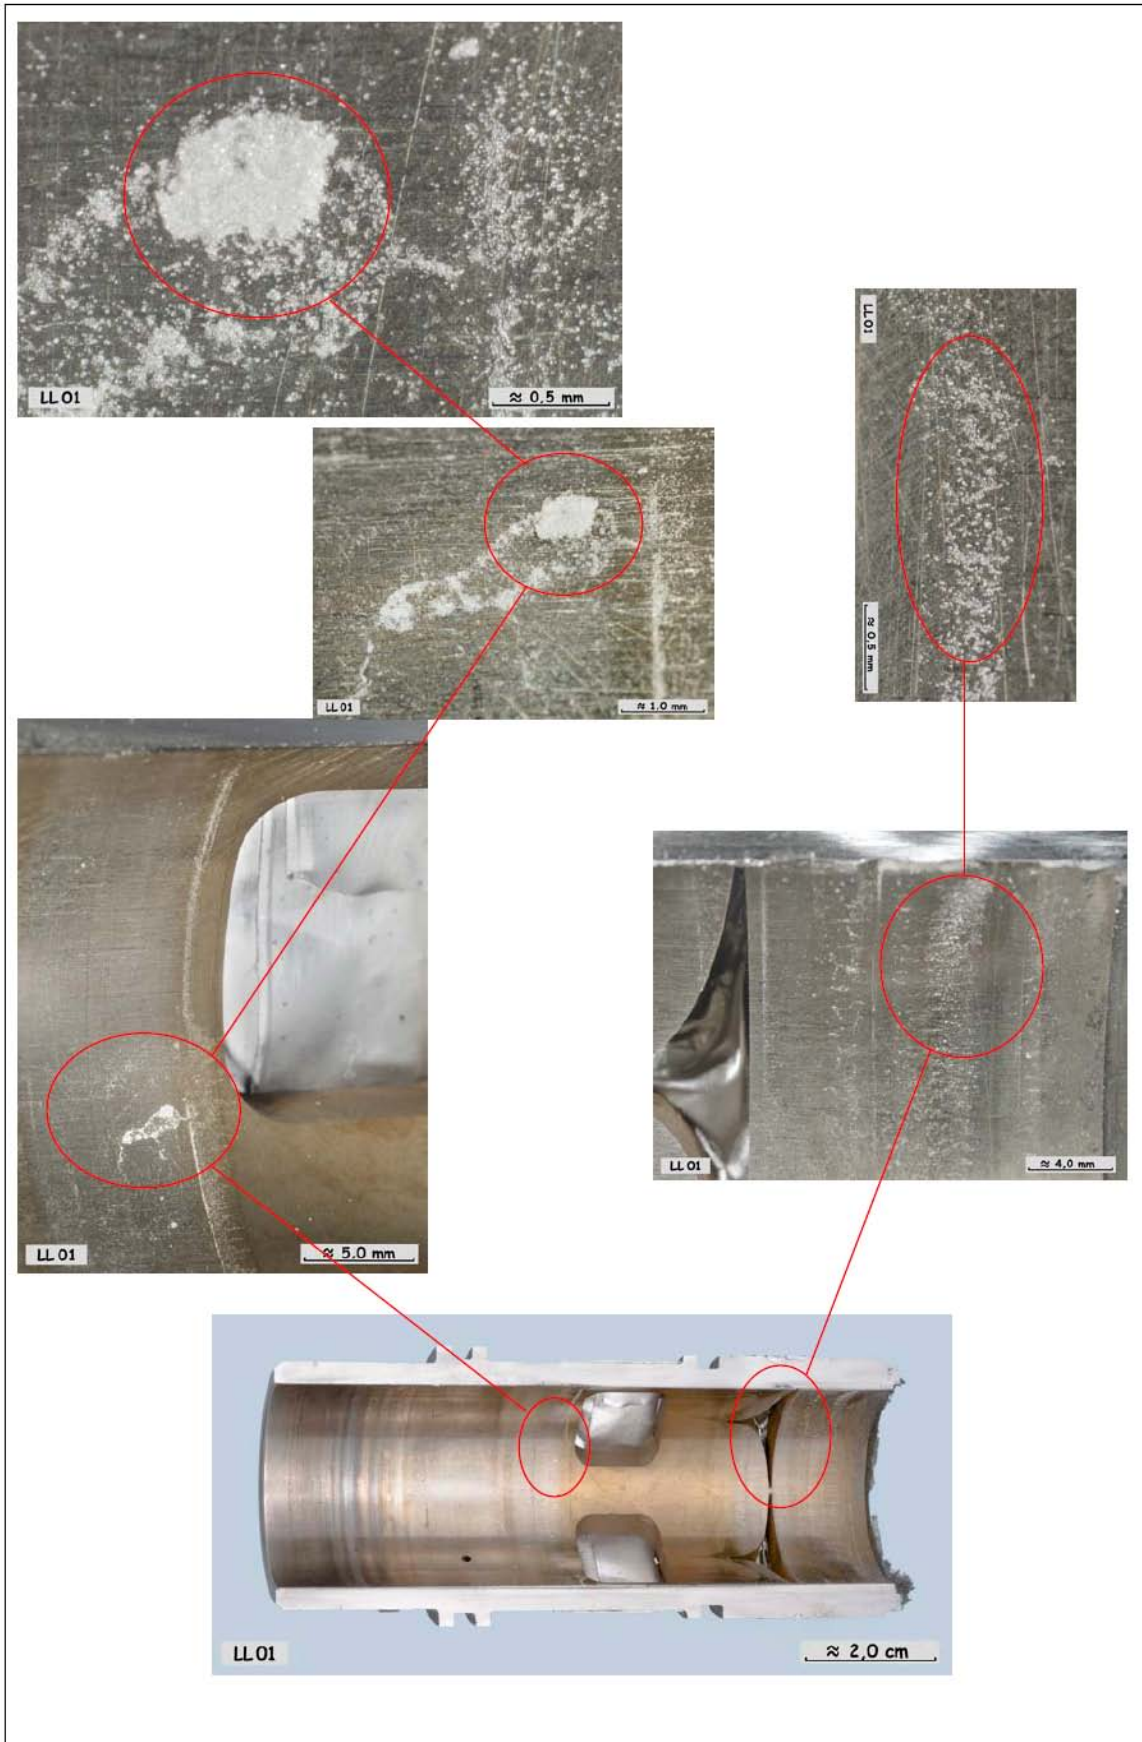
7. All the FDR data, QAR data, the PFR and the ACMS reports were reviewed and analysed. There was no evidence of unusual command signal from the Electronic Engine Control (EEC), the manual thrust, and the auto thrust systems. The engine fuel system components were subject to detailed examination. This revealed that the MMV in the FMU of both engines were seized at positions consistent with the corresponding final engine power. The VSVC from No. 2 engine was also found seized. These seizures were caused by contaminant in the form of fine spherical particles (spheres), evidence of which was found throughout the engine fuel system and in fuel samples from the aircraft tanks. The abnormal engines performance during the flight was believed to have been caused by stiction and eventual seizure of the MMV.

8. The spheres that seized the MMV of the FMU of both engines were in the order of 5 to 20 microns in size (see Figure 1). In other areas of the fuel system, spheres of 30 microns in size were also identified. Analysis showed that the spheres contained carbon, oxygen, sodium, chlorine, and sulphur (see Figure 2) and were mainly sodium polyacrylate, which was consistent with the super absorbent polymer (SAP) material used in the filter monitors on a fuelling dispenser. Further analysis revealed the presence of crystalline sodium chloride on the surface of some spheres (see Figure 3). [Note: Filter monitor removes small amount of particulate matter and dispersed free water from aviation fuel. On contact with water, the SAP absorbs the water and turns into gel that swells to fill the monitor, and in extreme situations, the gelling process may shut off the flow across the monitor completely.]

Figure 1: The cut-away view of No. 1 engine MMV sleeve showing the presence of spheres. Similar spheres were also present in No.2 engine MMV sleeve.

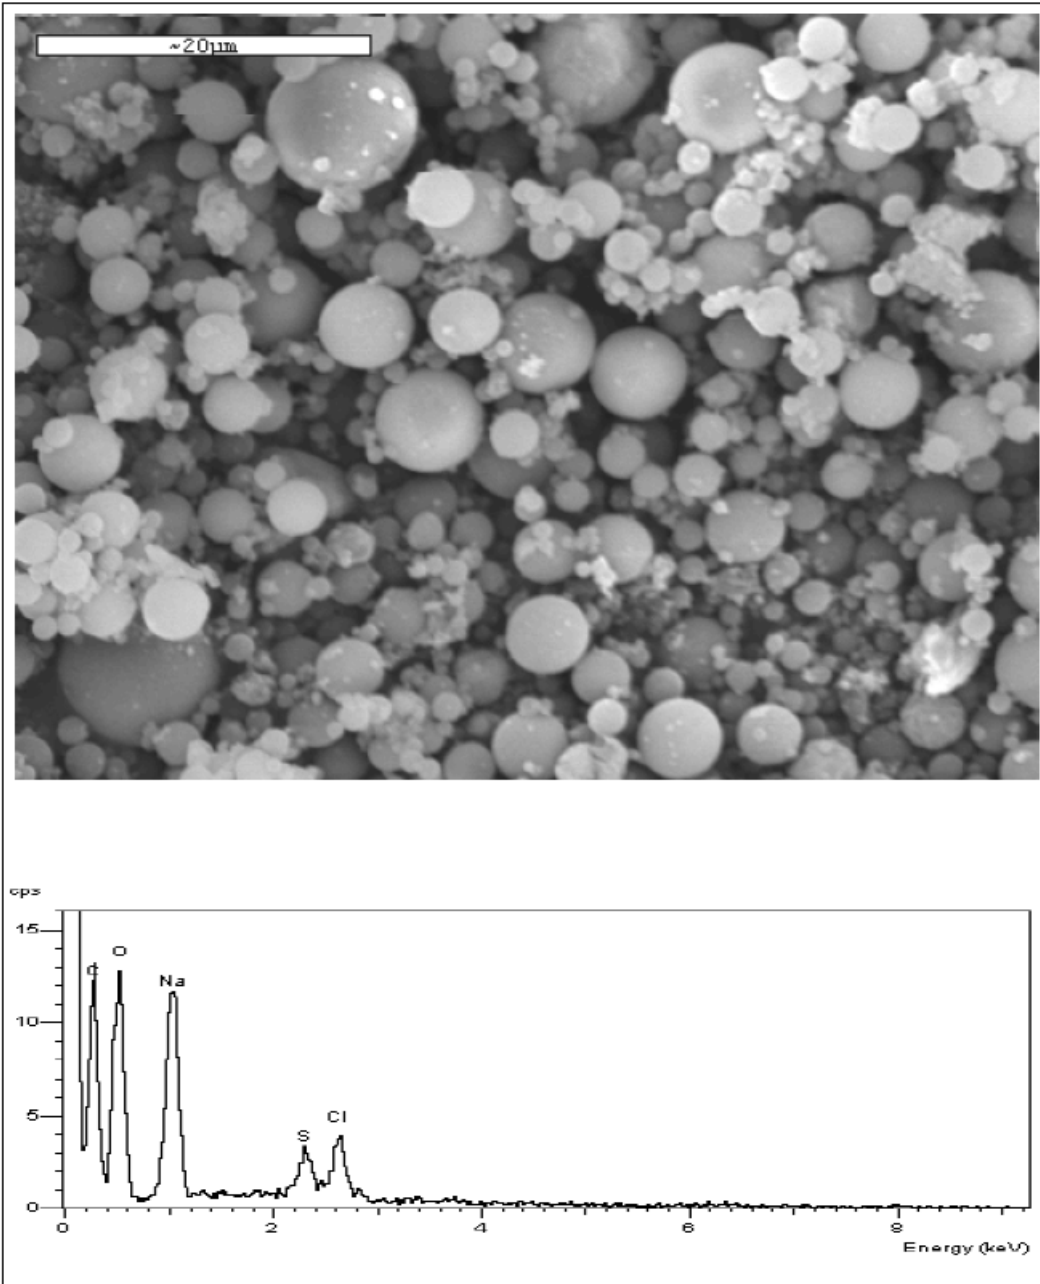
Figure 2: Microscopic view of spheres and their composition under Scanning Electronic Microscope (SEM) analysis.

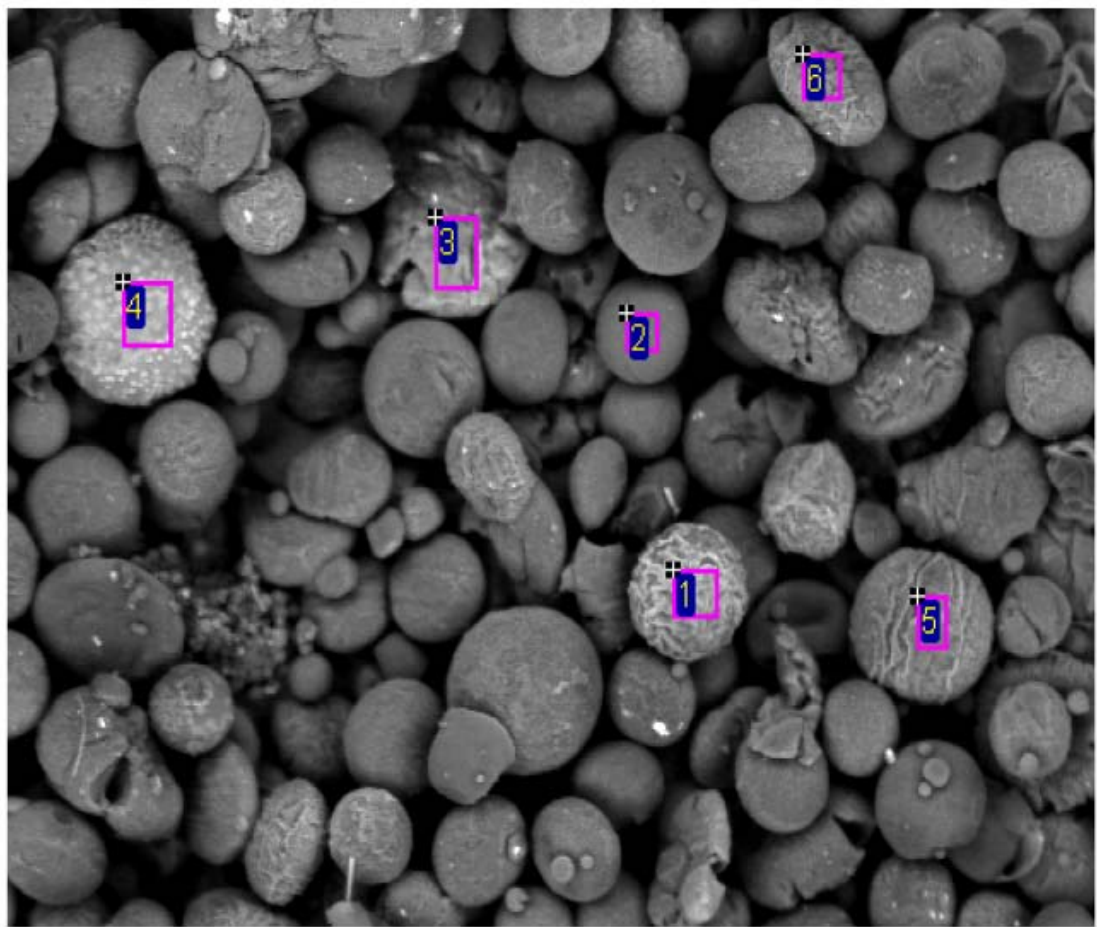
Spectrum	C	O	Na	S	Cl	
1	51.71	30.98	13.40	0.58	3.33	More Cl (and presumably NaCl) on brighter spheres
2	71.52	20.42	7.39	0.25	0.42	
3	53.93	29.74	11.60	0.60	4.13	More Cl (and presumably NaCl) on brighter spheres
4	35.50	42.06	16.46	2.83	3.15	More Cl (and presumably NaCl) on brighter spheres
5	54.82	32.16	11.47	0.46	1.08	
6	54.87	31.48	10.69	0.66	2.30

Figure 3: The presence of crystalline sodium chloride on the surface of some spheres.

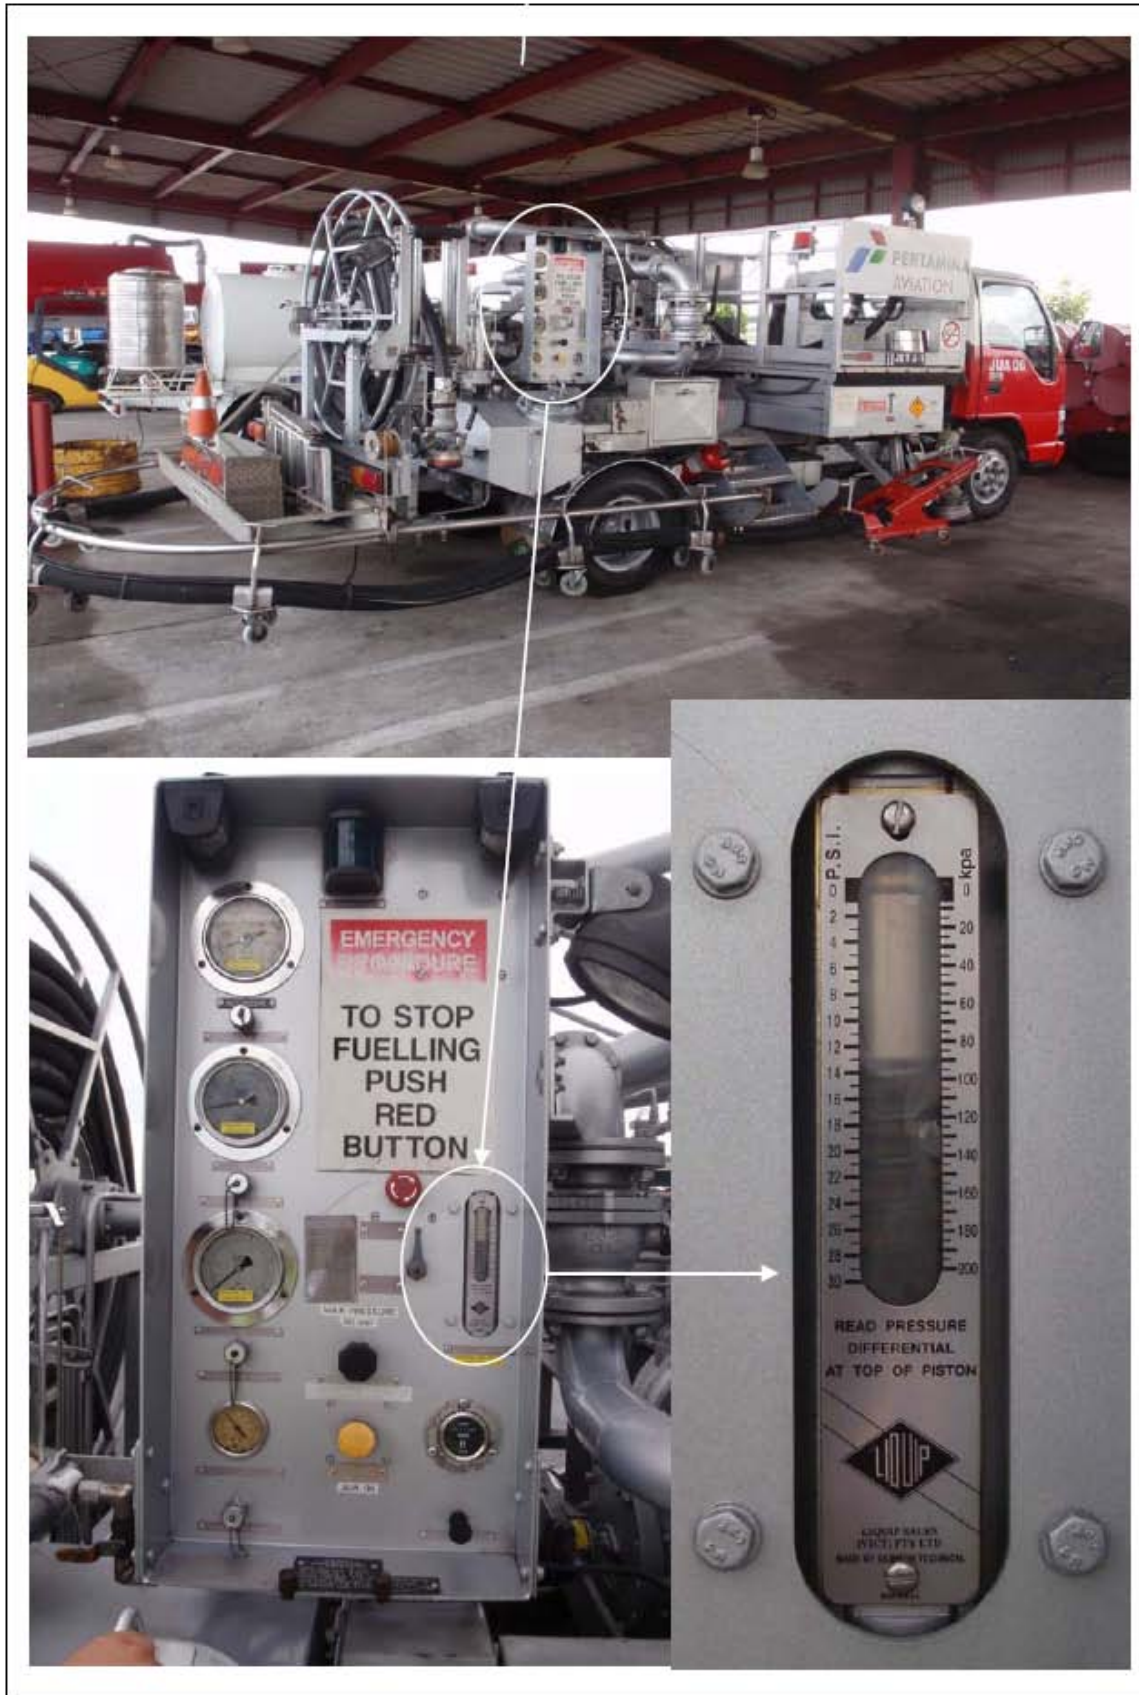
- The dispensers were mostly operated at flow rates well below the capacity defined by the dispenser manufacturer. Such low flow rate operation could reduce the effectiveness of the differential pressure monitoring (See Figure 4), which a high differential pressure would indicate clogging of the filter monitors in the dispenser, and therefore possible contamination of the fuel.

- The recording and monitoring of the weekly differential pressure of the dispensers was not performed properly. The differential pressure reading, which was taken under low flow rates during refuelling operation, may not have correctly indicated the condition of the filter monitors.

Figure 4: The differential pressure gauge of a dispenser.

16. After being advised of the occurrence and the probable ground fuel contamination at WARR, Pertamina had initiated a number of remedial actions including enhancing the monitoring of the dispenser differential pressure, and arranged an independent review by an aviation fuel expert on WARR's aviation fuel supply system and operation. At the time of writing this Bulletin, the NTSC has informed the CAD that Pertamina has taken additional measures to monitor the delivery of aviation fuel into aircraft at WARR, and developed an action plan for enhancement.

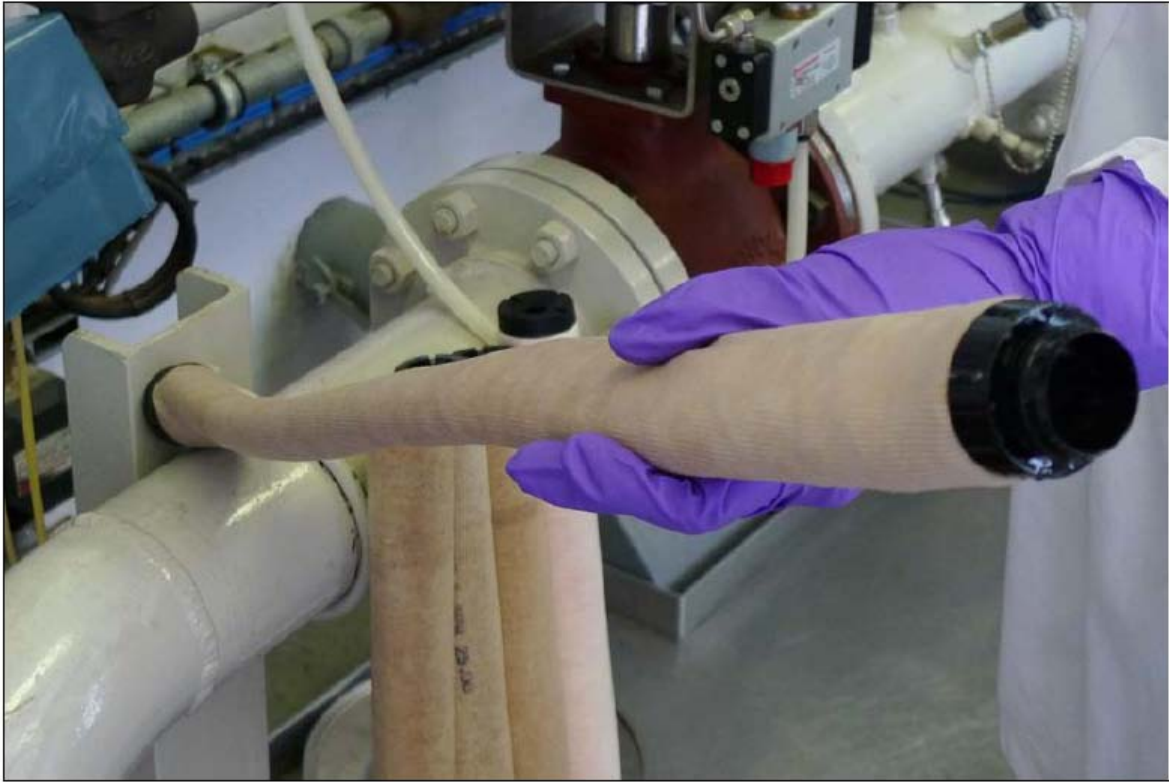
17. It was noticed that one of the forty filter monitors (Model FG-230-4) was found collapsed when it was being removed from dispenser JUA06 for the investigation. Subsequent tests showed that the collapsed FG-230-4 did not allow flow across the monitor when installed in a test rig. Further test on similar FG-230-4 demonstrated that they could be collapsed in a bulk water "slug" test and a collapsed monitor could lose their structural rigidity and shorten in length by up to 20 mm (See Figure 5a and 5b). A study of the installation of FG-230-4 inside the filter vessel of the dispenser indicated that a collapsed FG-230-4 could be dislodged inside the vessel when there is sufficient back pressure, which could result in fuel bypassing the filtration system. Nevertheless, occurrence of filter bypass in previous refuelling could not be established.

18. The FG-230-4 support core is metallic and should withstand a differential pressure of 12 bars to meet the specification defined in document EI 1583 "Laboratory tests and minimum performance levels for aviation fuel filter monitors" 4th Edition. The manufacturer of this filter monitor, Facet International (Facet), indicated that their FG-230-4 passed annual quality testing which include the collapse pressure test. However, Facet conducted additional tests after this occurrence on FG-230-4 from the stock of various lots and the results showed a collapse pressure of 11 to 11.5 bar range which would fall below the 12 bar requirement. In a typical operating conditions, the refuelling system will seldom reach 11 bar pressure and a 12 bar requirement is in place to include a considerable margin above typical operation. At the time of writing this Bulletin, Facet was redesigning the FG-230-4 to provide additional strength.

Figure 5a: A collapsed monitor loses the structural rigidity.

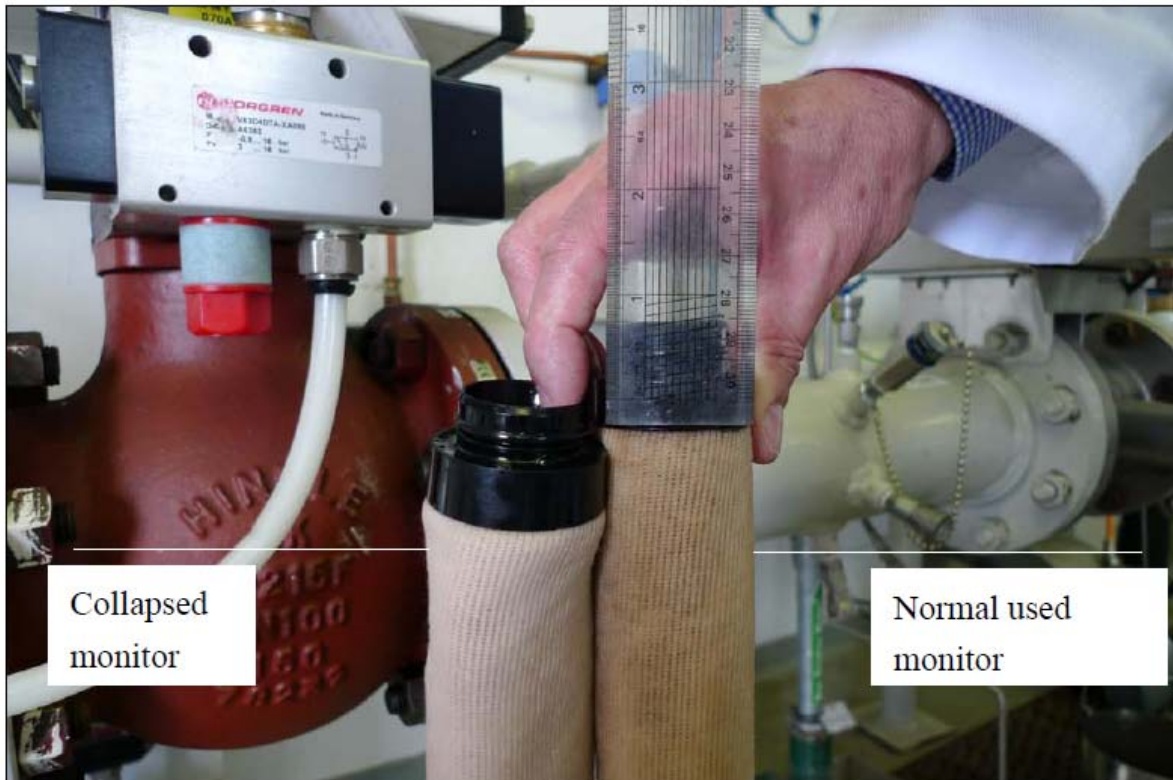
Figure 5b: A collapsed monitor is shorter than a normal monitor.
