**Accident Bulletin 1/2012**

**(An Update Bulletin to Accident Bulletin 2/2011)**

**Update on Investigation into  
Aircraft Accident to the Government Flying Service Eurocopter AS332 L2, B-HRN  
during Fire Fighting Operation on 27 December 2010**

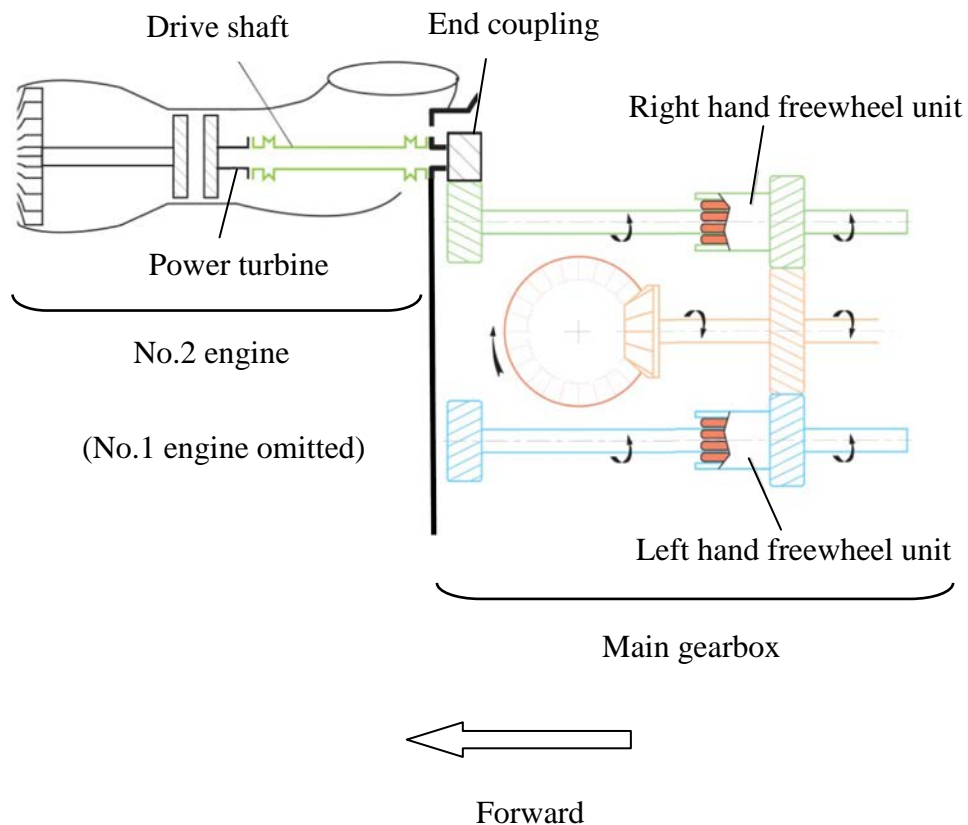
Figure 1 AS332 L2 Super Puma Engine to Main Gearbox Connection Configuration

6. The investigation so far did not identify evidence indicating that there was any anomaly internal to engine. Since the power turbine of both engines is a free turbine and it is mechanically connected to the corresponding freewheel unit inside the MGB, the team pursued investigation into a genuine overspeed of No.2 engine power turbine due to possibly a momentary 'disconnect' from the MGB.

7. The MGB, including the two freewheel units inside, were closely examined. There were no signs of damage. The condition of the right freewheel unit was similar to other freewheel units observed in overhaul, except that the level of fretting wear on the ramps of the freewheel shaft was a little higher than usual. On two of the ramps, there were signs and marks of roller sliding longitudinally. On other ramps, vertical scratch marks and metal pickup were observed indicating that the rollers could have slipped.
