Accident Bulletin 2/2012
(An update to Accident Bulletin 3/2011)

Aircraft type:	Aerospatiale SA 315B LAMA helicopter
Registration:	B-HJV
Year of manufacture:	1972
Number and type of engines:	One Turbomeca Artouste IIIB turboshaft engine
Date and time of accident:	3 January 2011 at around 0556 hrs UTC (1356 local time) Note : Hong Kong local time is UTC time + 8 hours
Place of accident:	Kau Lung Hang Lo Wai, Fanling, New Territories, Hong Kong
Nature of Accident:	<p>The helicopter was conducting an underslung load operation on the hillside of Kau Lung Hang Lo Wai, Fanling. When the helicopter was setting down a load onto a work site located near an overhead high voltage electricity line pole, a sudden flash of fire occurred adjacent to the power cables below the helicopter. The generated sparks and smoke cascaded onto the ground, causing injuries to two ground workers.</p> <p>After the accident, the helicopter climbed out of the site and returned to its base in Sek Kong. The underslung assembly and several items of the aircraft equipment were found to have been damaged.</p>

**Update on Investigation of Helicopter Accident involving
the Aerospatiale SA 315B LAMA (Registration Mark

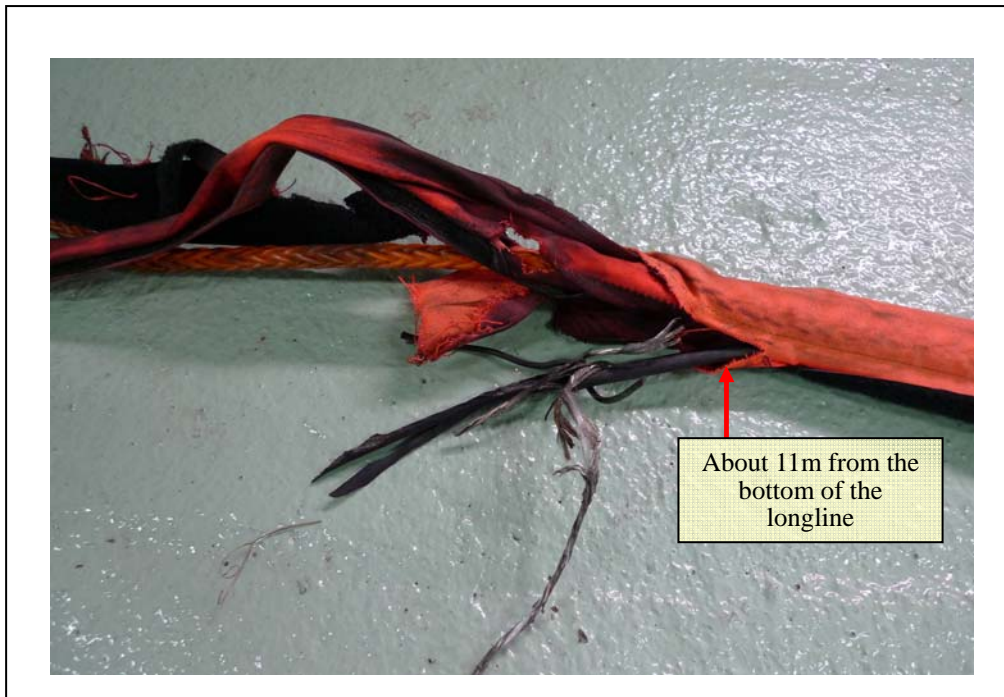
3. The lower 11 metres of the 100-foot (30.5 metres) longline’s protective nylon jacket was found to have been crisped and fragmented with a large portion of the shrouded electrical cable missing (see Figure 1). The remote-controlled hook which was connected to the bottom end of the longline was charred, showing clear burn marks and signs of flashover (see Figure 2). The length of this damaged section of the longline was consistent with the height of the overhead lines at Pole 9 of the “Fanling – Ting Kok Road No. 1 132 Kilovolts Overhead Line Circuit (“FNL-TKR No. 1 Circuit”)” (See Figure 3).
4. Besides the longline, several items of the aircraft equipment on board the helicopter were found to have been damaged. These included the Automatic Direction Finder

Figure 1 : The lower 11 metres of the longline's protective nylon jacket was found to have been crisped and fragmented with a large portion of the shrouded electrical cable missing.

It is recommended that when operating in the vicinity of overhead high voltage electricity lines, the use of any underslung cable assemblies by Heliservices on Aerospatiale SA 315B LAMA helicopters, which consists of electrical conducting material, should be suspended until completion of the investigation or a further recommendation is issued.

10. After the accident, Heliservices has suspended the use of the longlines which incorporate a shrouded electrical cable. Heliservices has also suspended all of its underslung operations in the vicinity of overhead high voltage electricity lines.
11. If there are other safety recommendations deemed necessary during the course of the investigation, they will be promulgated immediately.

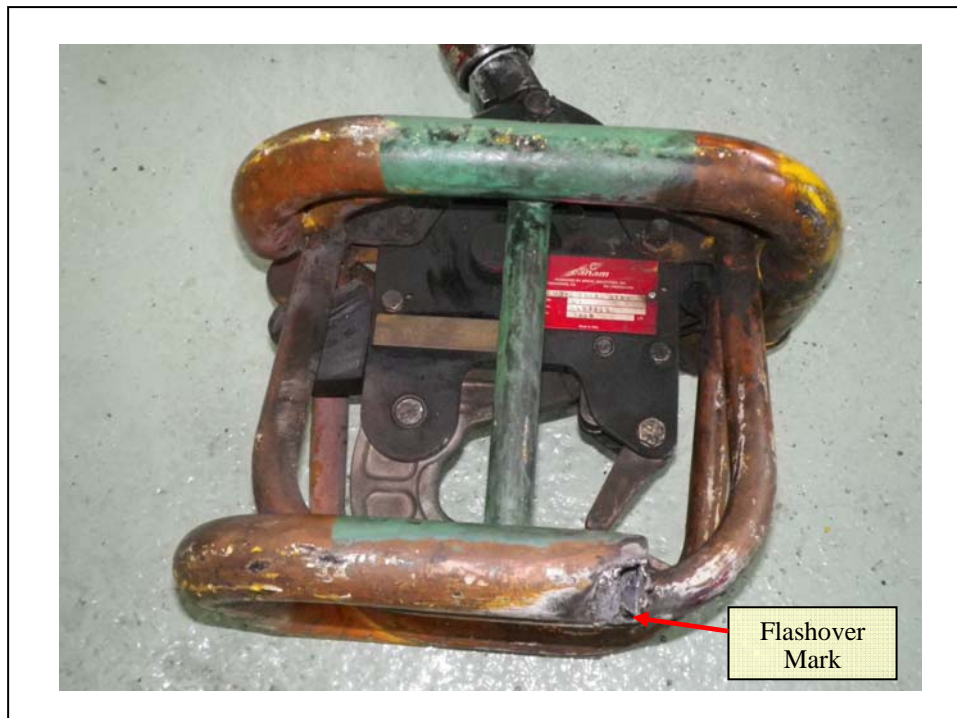
Figure 2 : The remote-controlled hook which was connected to the bottom end of the longline was charred, showing clear burn marks and signs of flashover.

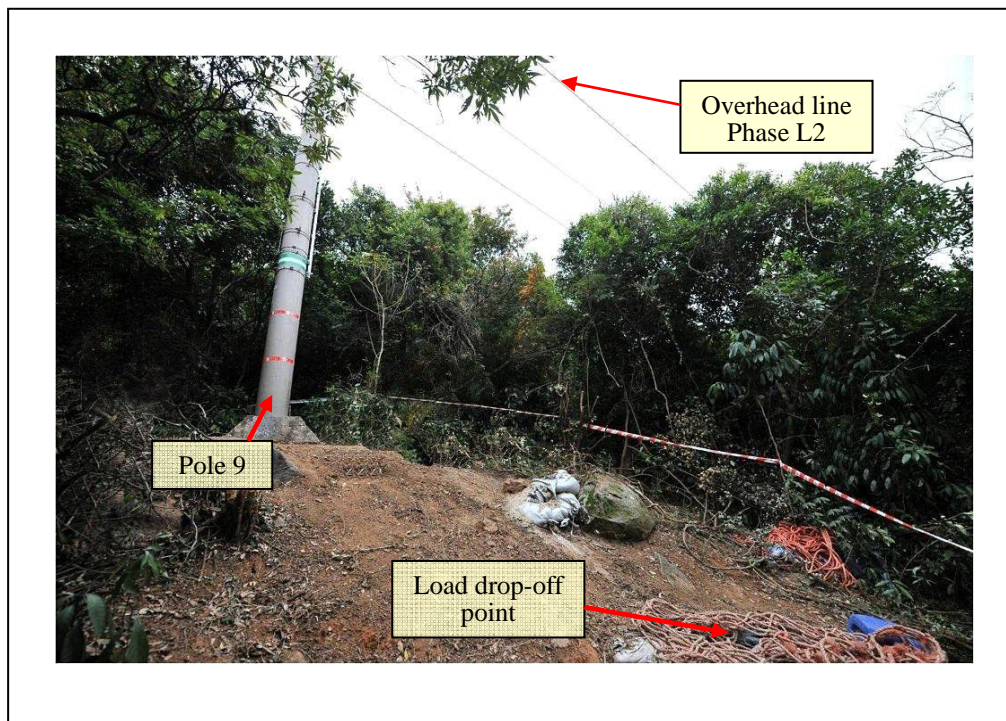
Figure 4 : The relative location of Pole 9 of the “FNL-TKR No. 1 Circuit” and the accident work site

5. At Pole 9, there were three live overhead lines located on the two sides of the supporting pole, namely Phase L1, Phase L2 and Phase L3, with Phase L2 located at the side on which the underslung load operation was conducted (see Figure 4). The event log of China Light and Power Limited (“CLP”) showed that within a short duration of approximately 168 milliseconds between 0556 and 0557 hrs (between 1356 and 1357 local time), there were substantial disturbances in the voltage and current waveforms of Phase L2. This indicated that a short circuit had occurred in Phase L2 of the FNL-TKR No. 1 Circuit. Phases L1 and L3 only showed minor consequential disturbance due to the short circuit in Phase L2, indicating that there was no short circuit in these phases.
