Task Force on Excessive Lead in Drinking Water

25 September 2015

Preliminary report

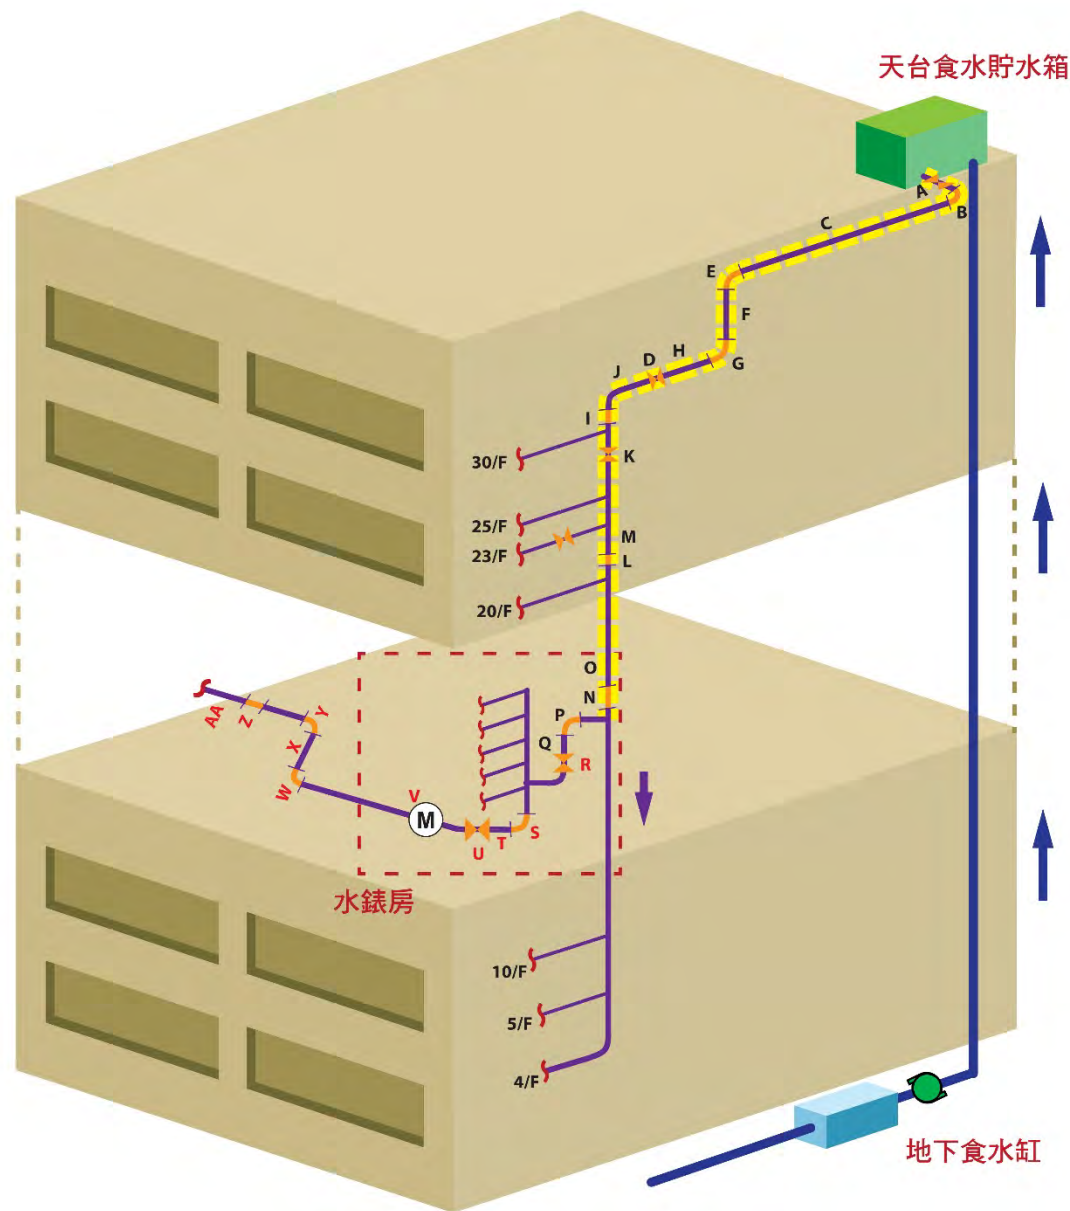
Downpipe from Roof to 14th Floor

Lead leaching from Cast Iron gate valves and copper downpipes / silver brazing joints with dia > 76mm **undetectable** or very minor*.

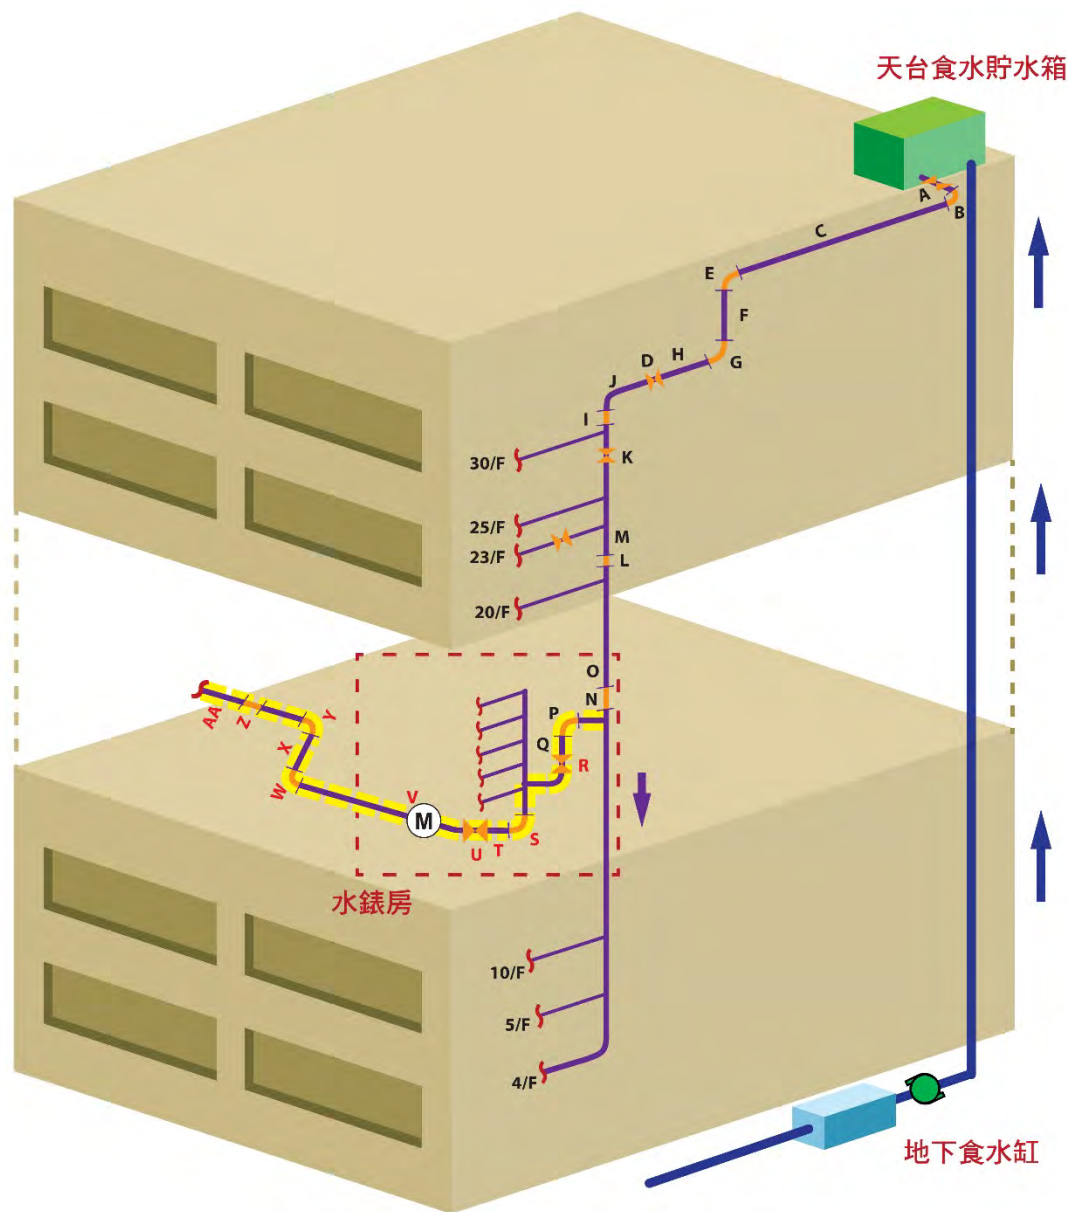
Branch pipe leading to residential flat

Lead leaching from copper alloy valves , meters and copper pipes / solder joints with dia $\leq 76\text{mm}$ **detectable**.

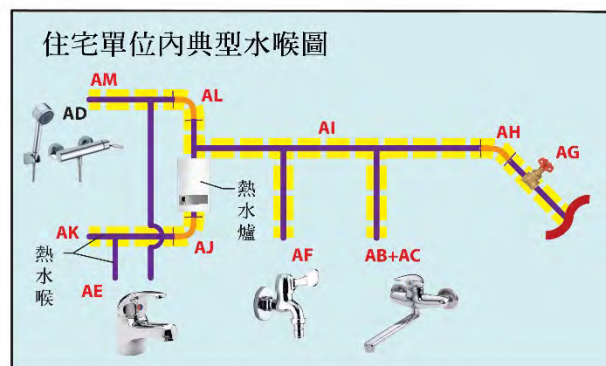
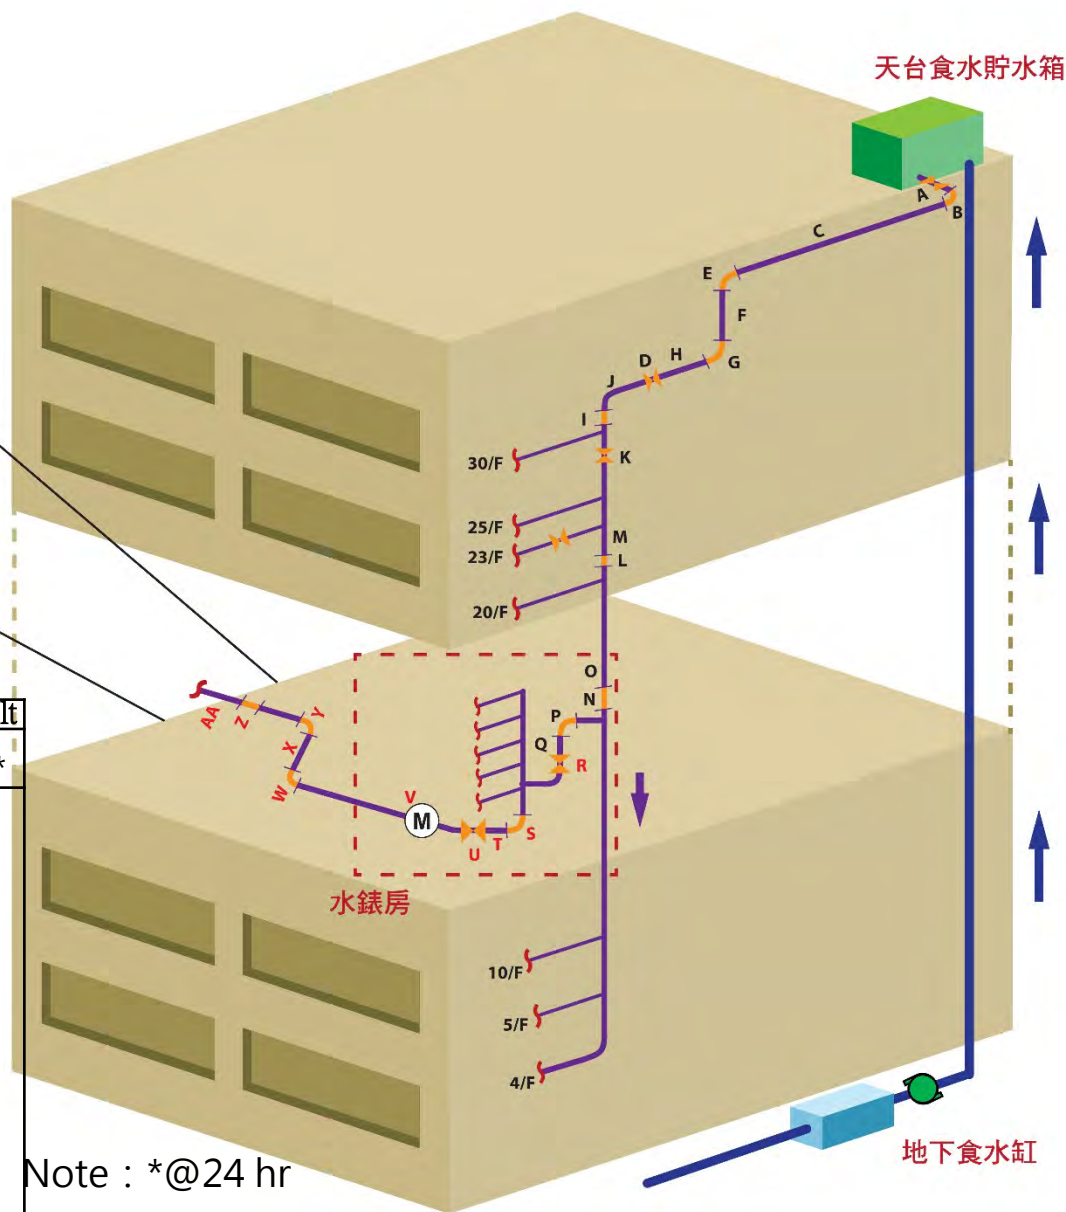
Branch pipe within residential flat

Lead leaching from copper alloy valves, taps, and copper pipes / solder joints with dia $\leq 76\text{mm}$ **detectable**.

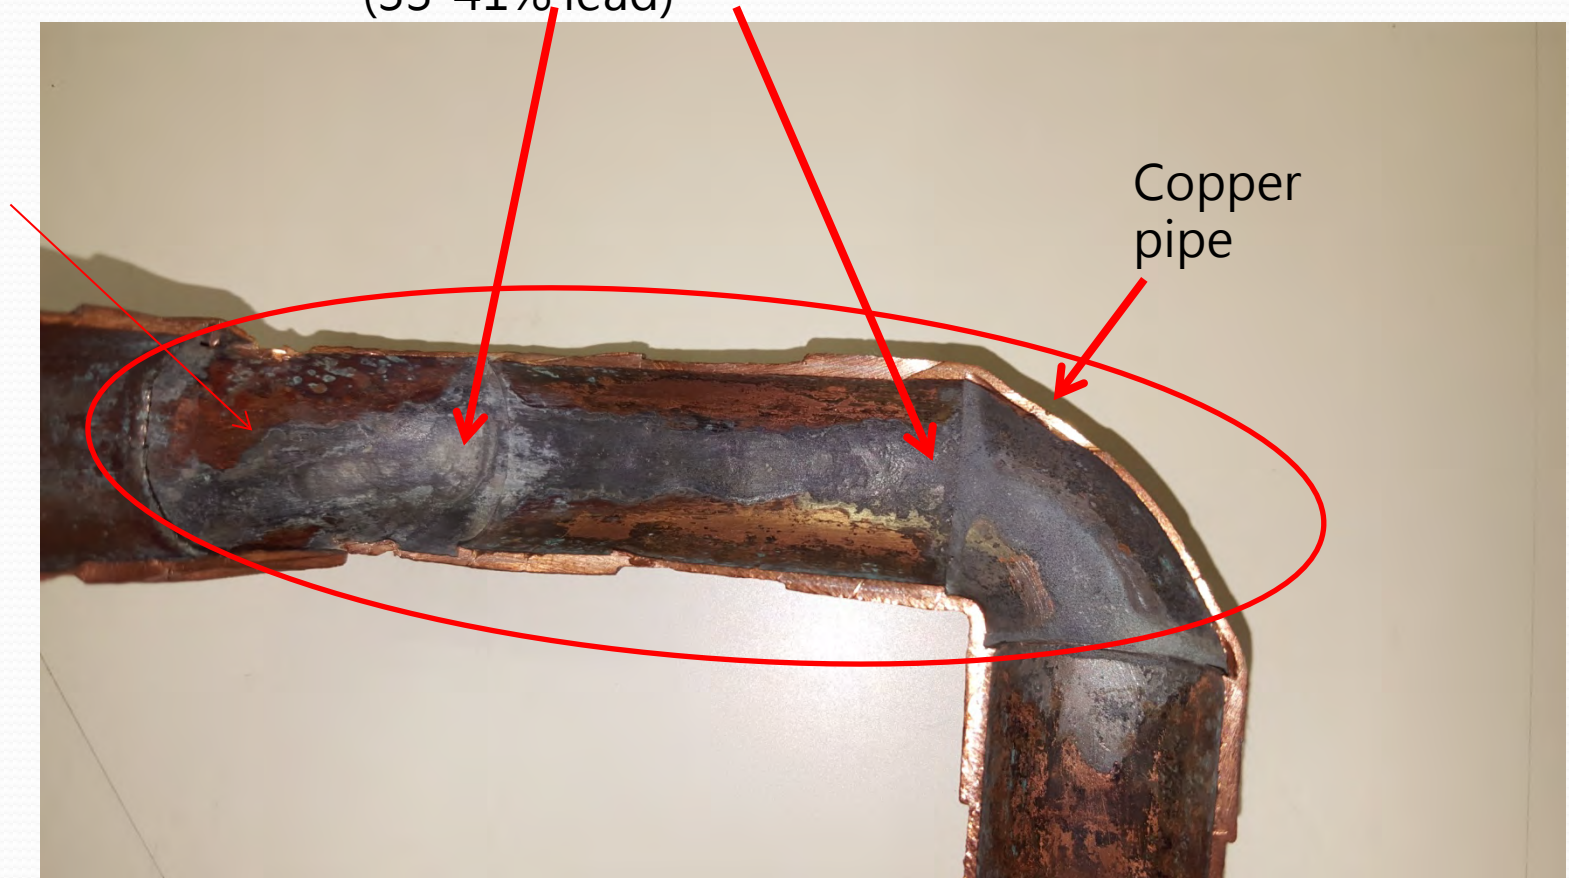
Leaded solder joints
(33-41% lead)

Lead solder seeped into the internal water surface due to unsatisfactory welding in some solder joints causing lead leaching.

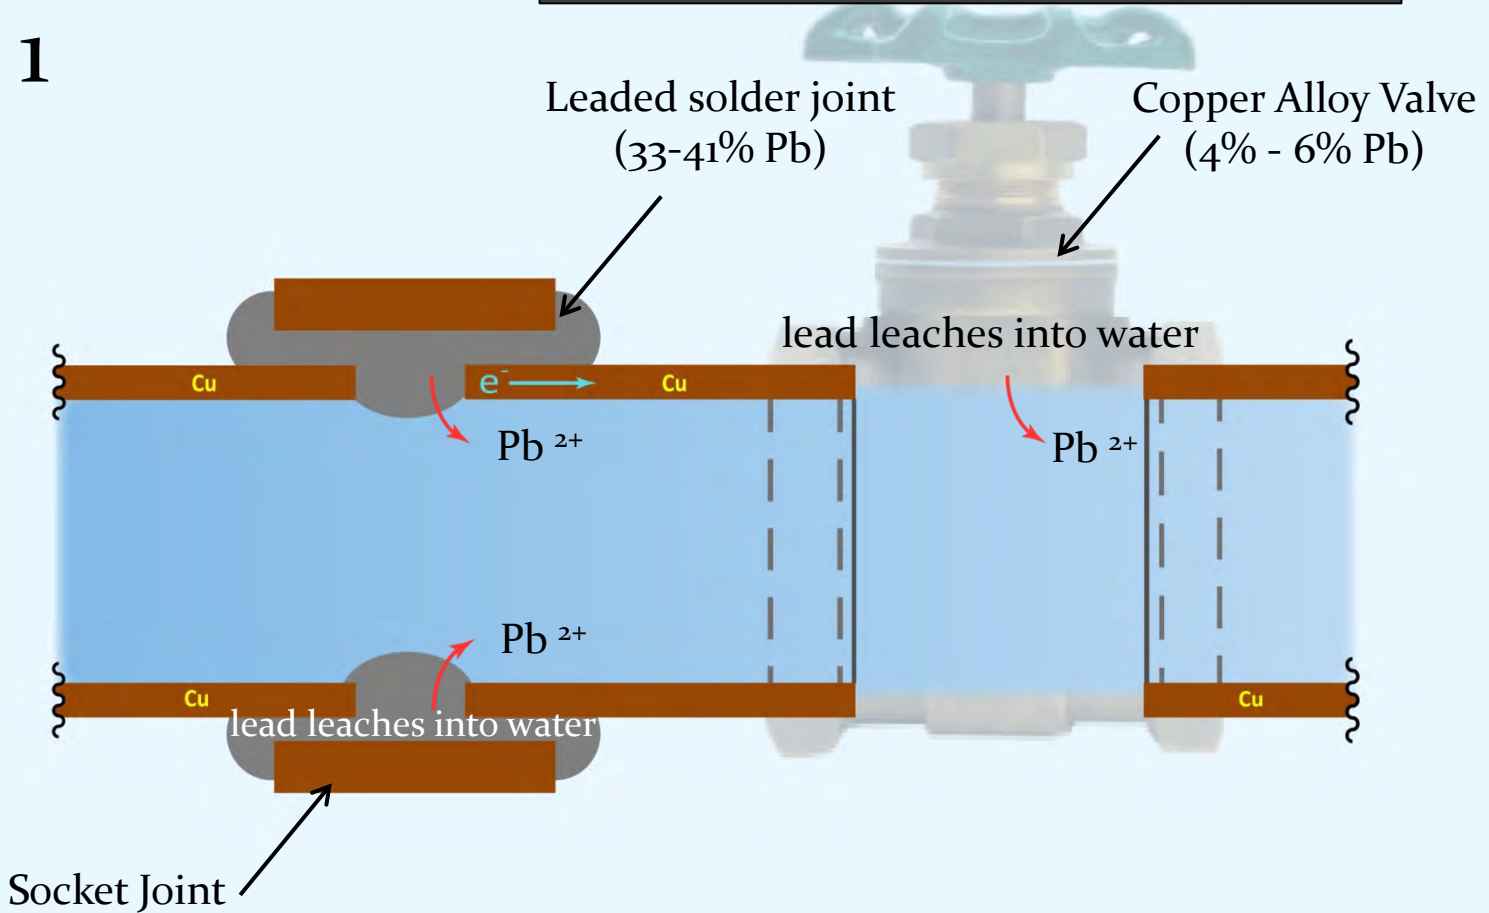
INITIAL SOURCE - Lead ions leached from leaded solder and copper alloy fittings by corrosion.

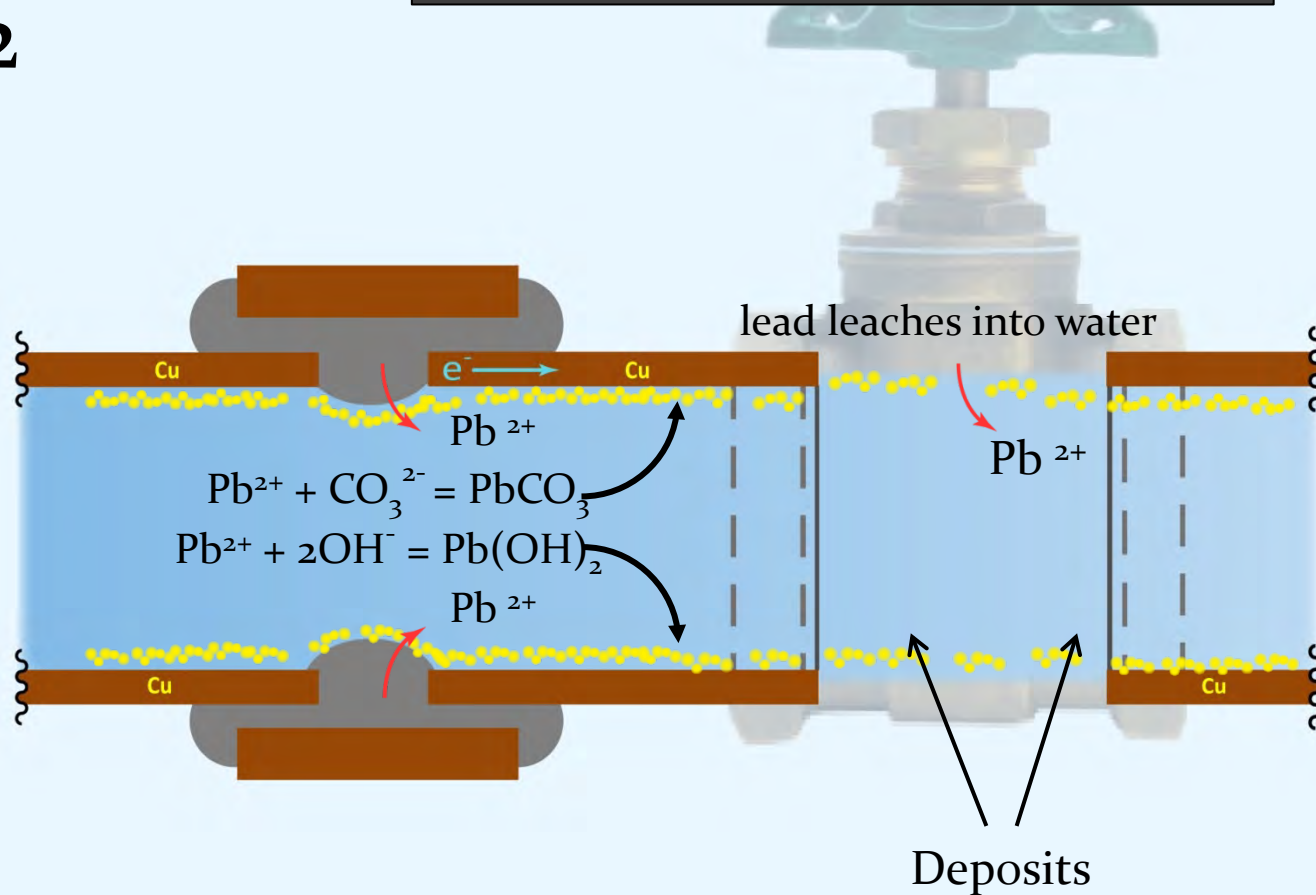
SUBSEQUENT SOURCE – Lead deposit formed by lead ions react with carbonate and hydroxide ions in water .

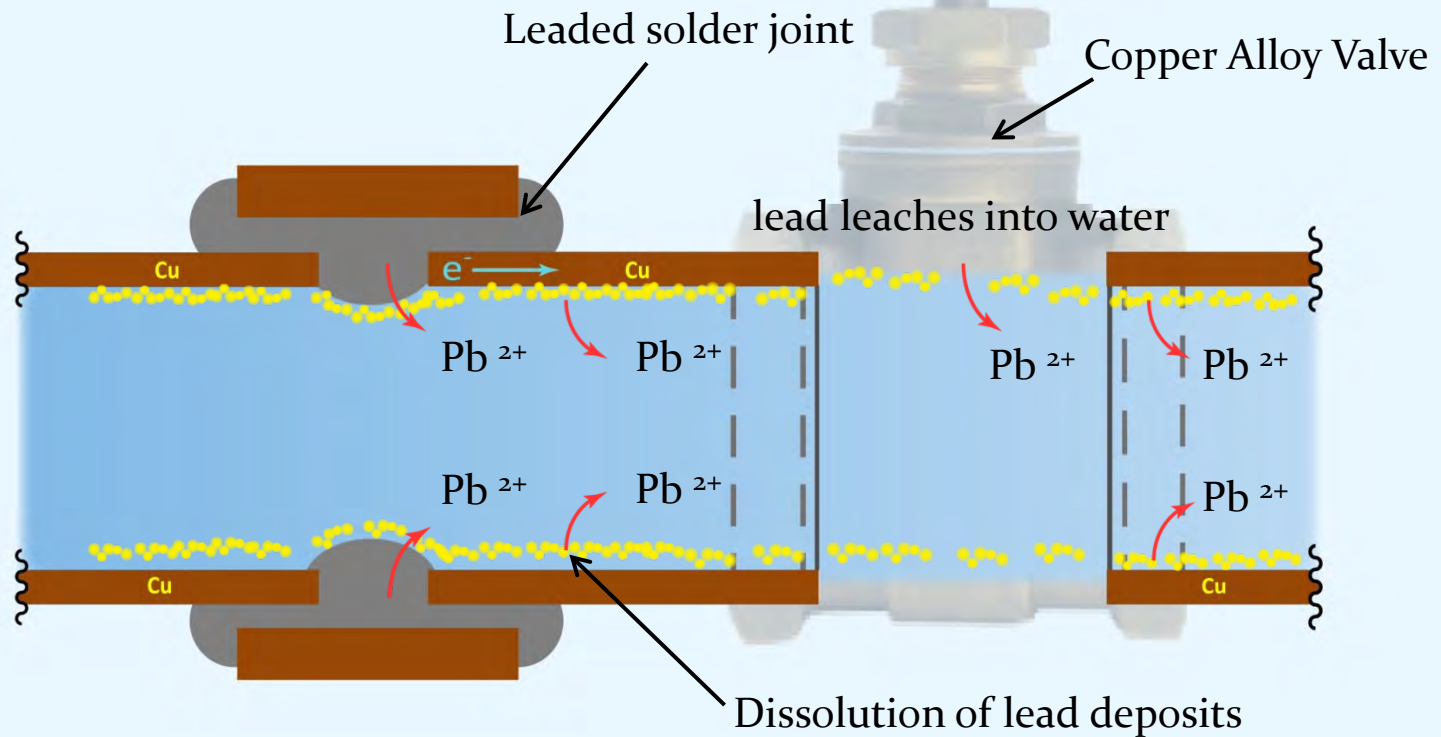
Source of Lead in water =
INITIAL SOURCE (lead leaching from leaded solder
and copper alloy fittings) +
SUBSEQUENT SOURCE (lead deposits)

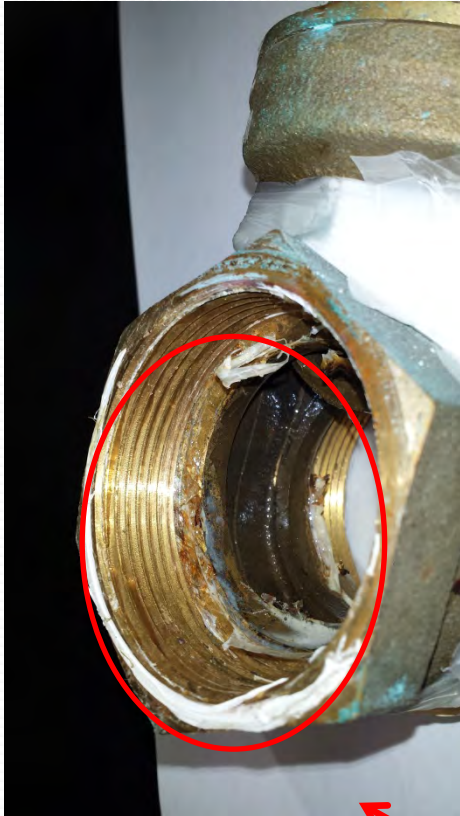
Copper Alloy Gate Valve

Lead deposits in branch pipes and pipe fittings

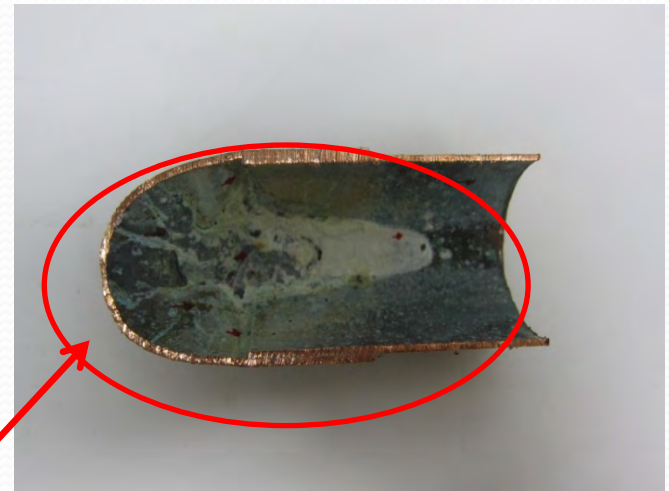
Copper pipe elbow

deposits
