Background Information for Press Release on Slope Safety before Wet Season in 2022

Dr Raymond Cheung
Head of Geotechnical Engineering Office

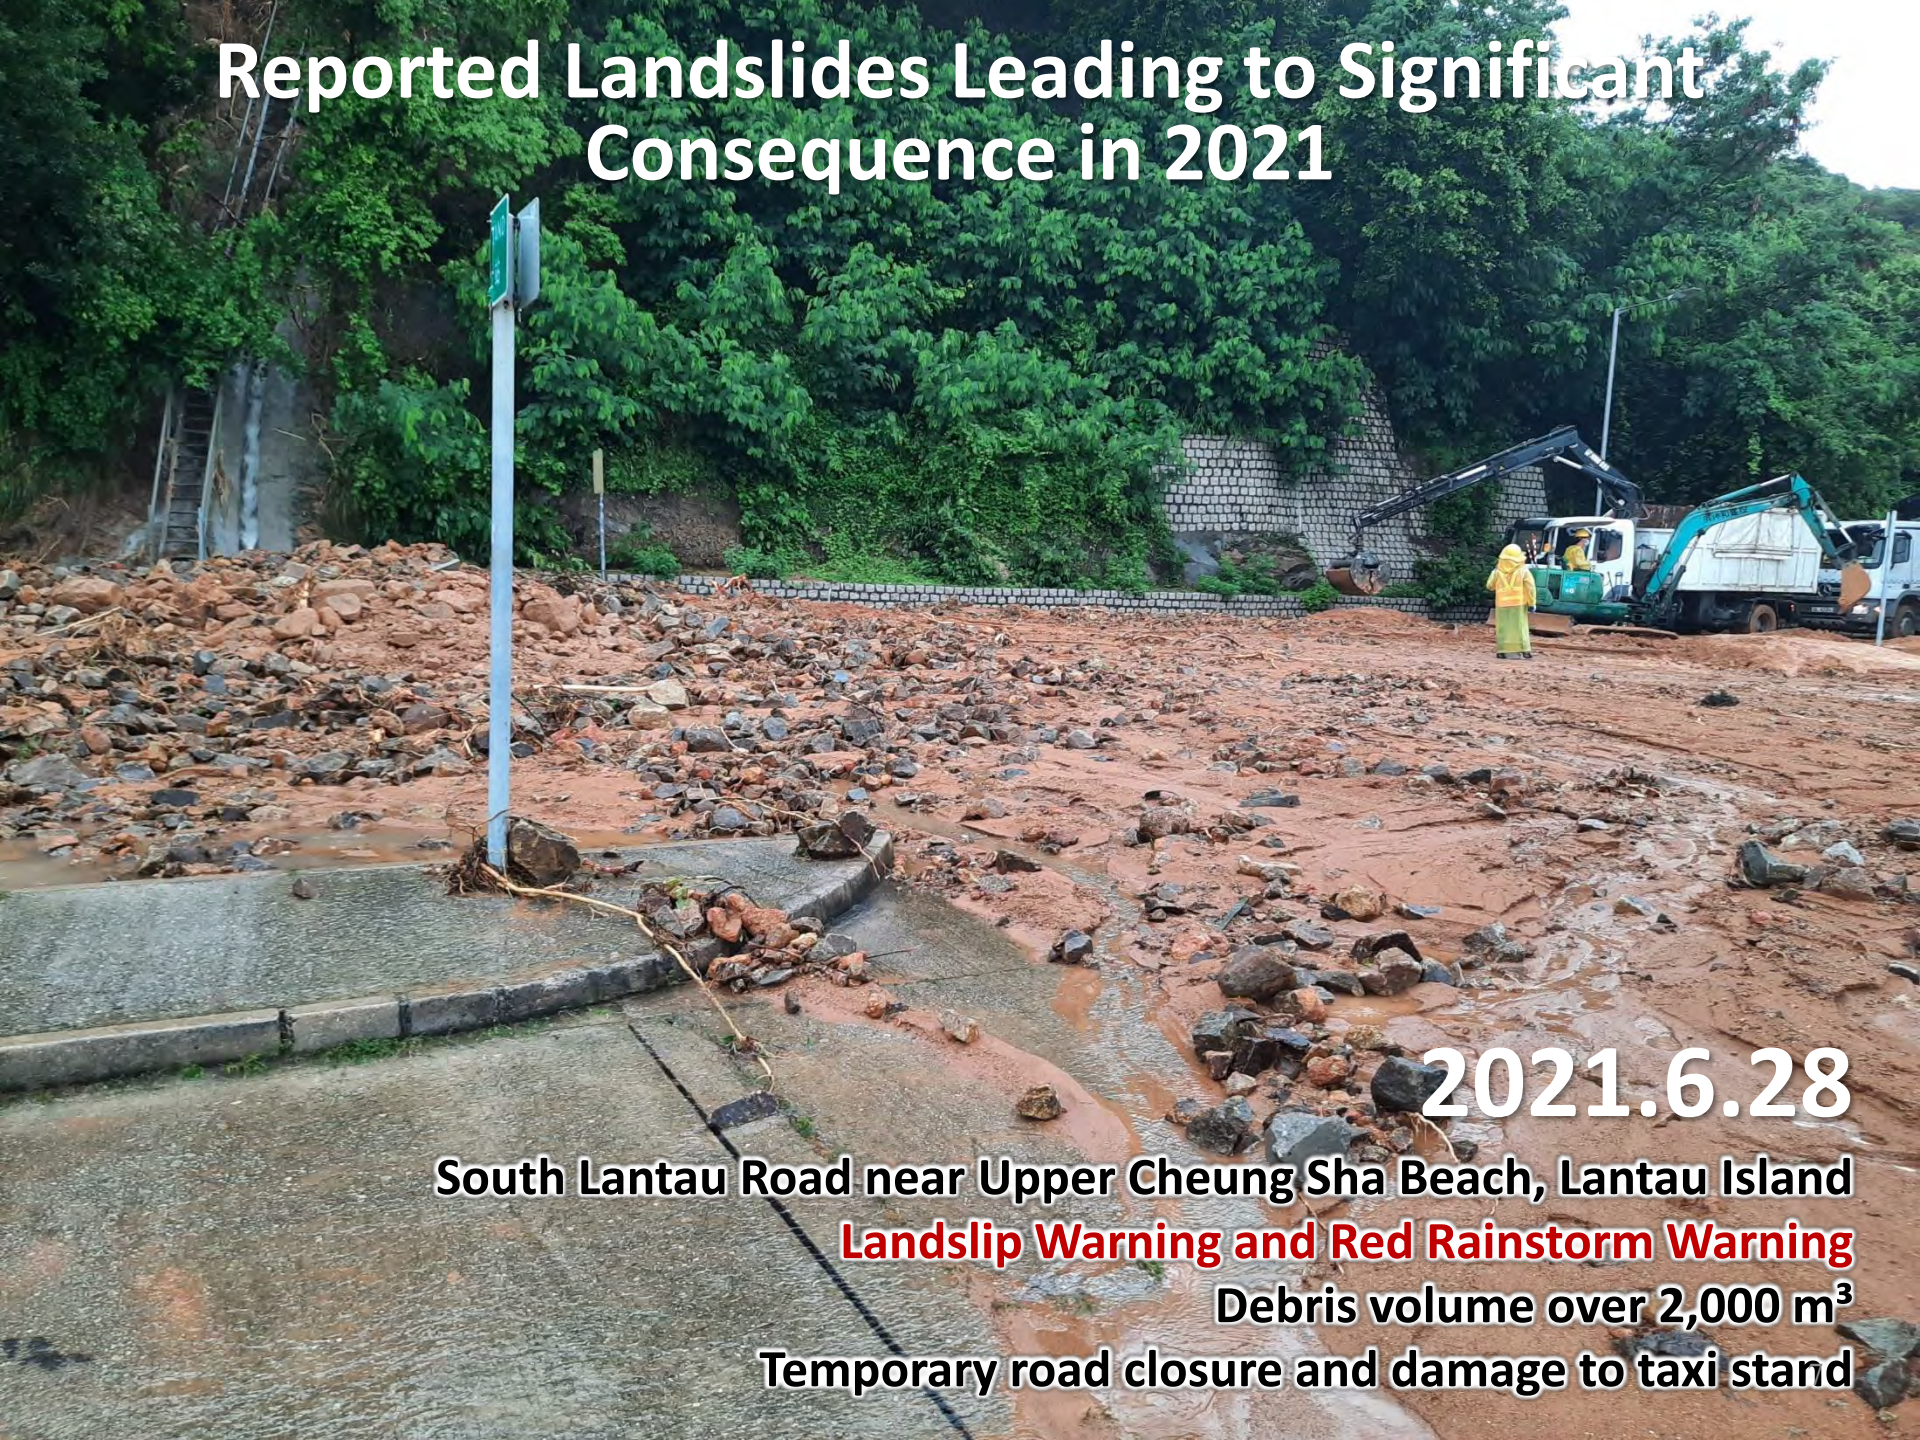
Reported Landslides Leading to Significant Consequence in 2021

2021.6.28

South Lantau Road near Upper Cheung Sha Beach, Lantau Island

Landslip Warning and Red Rainstorm Warning

Debris volume over 2,000 m³

Temporary road closure and damage to taxi stand

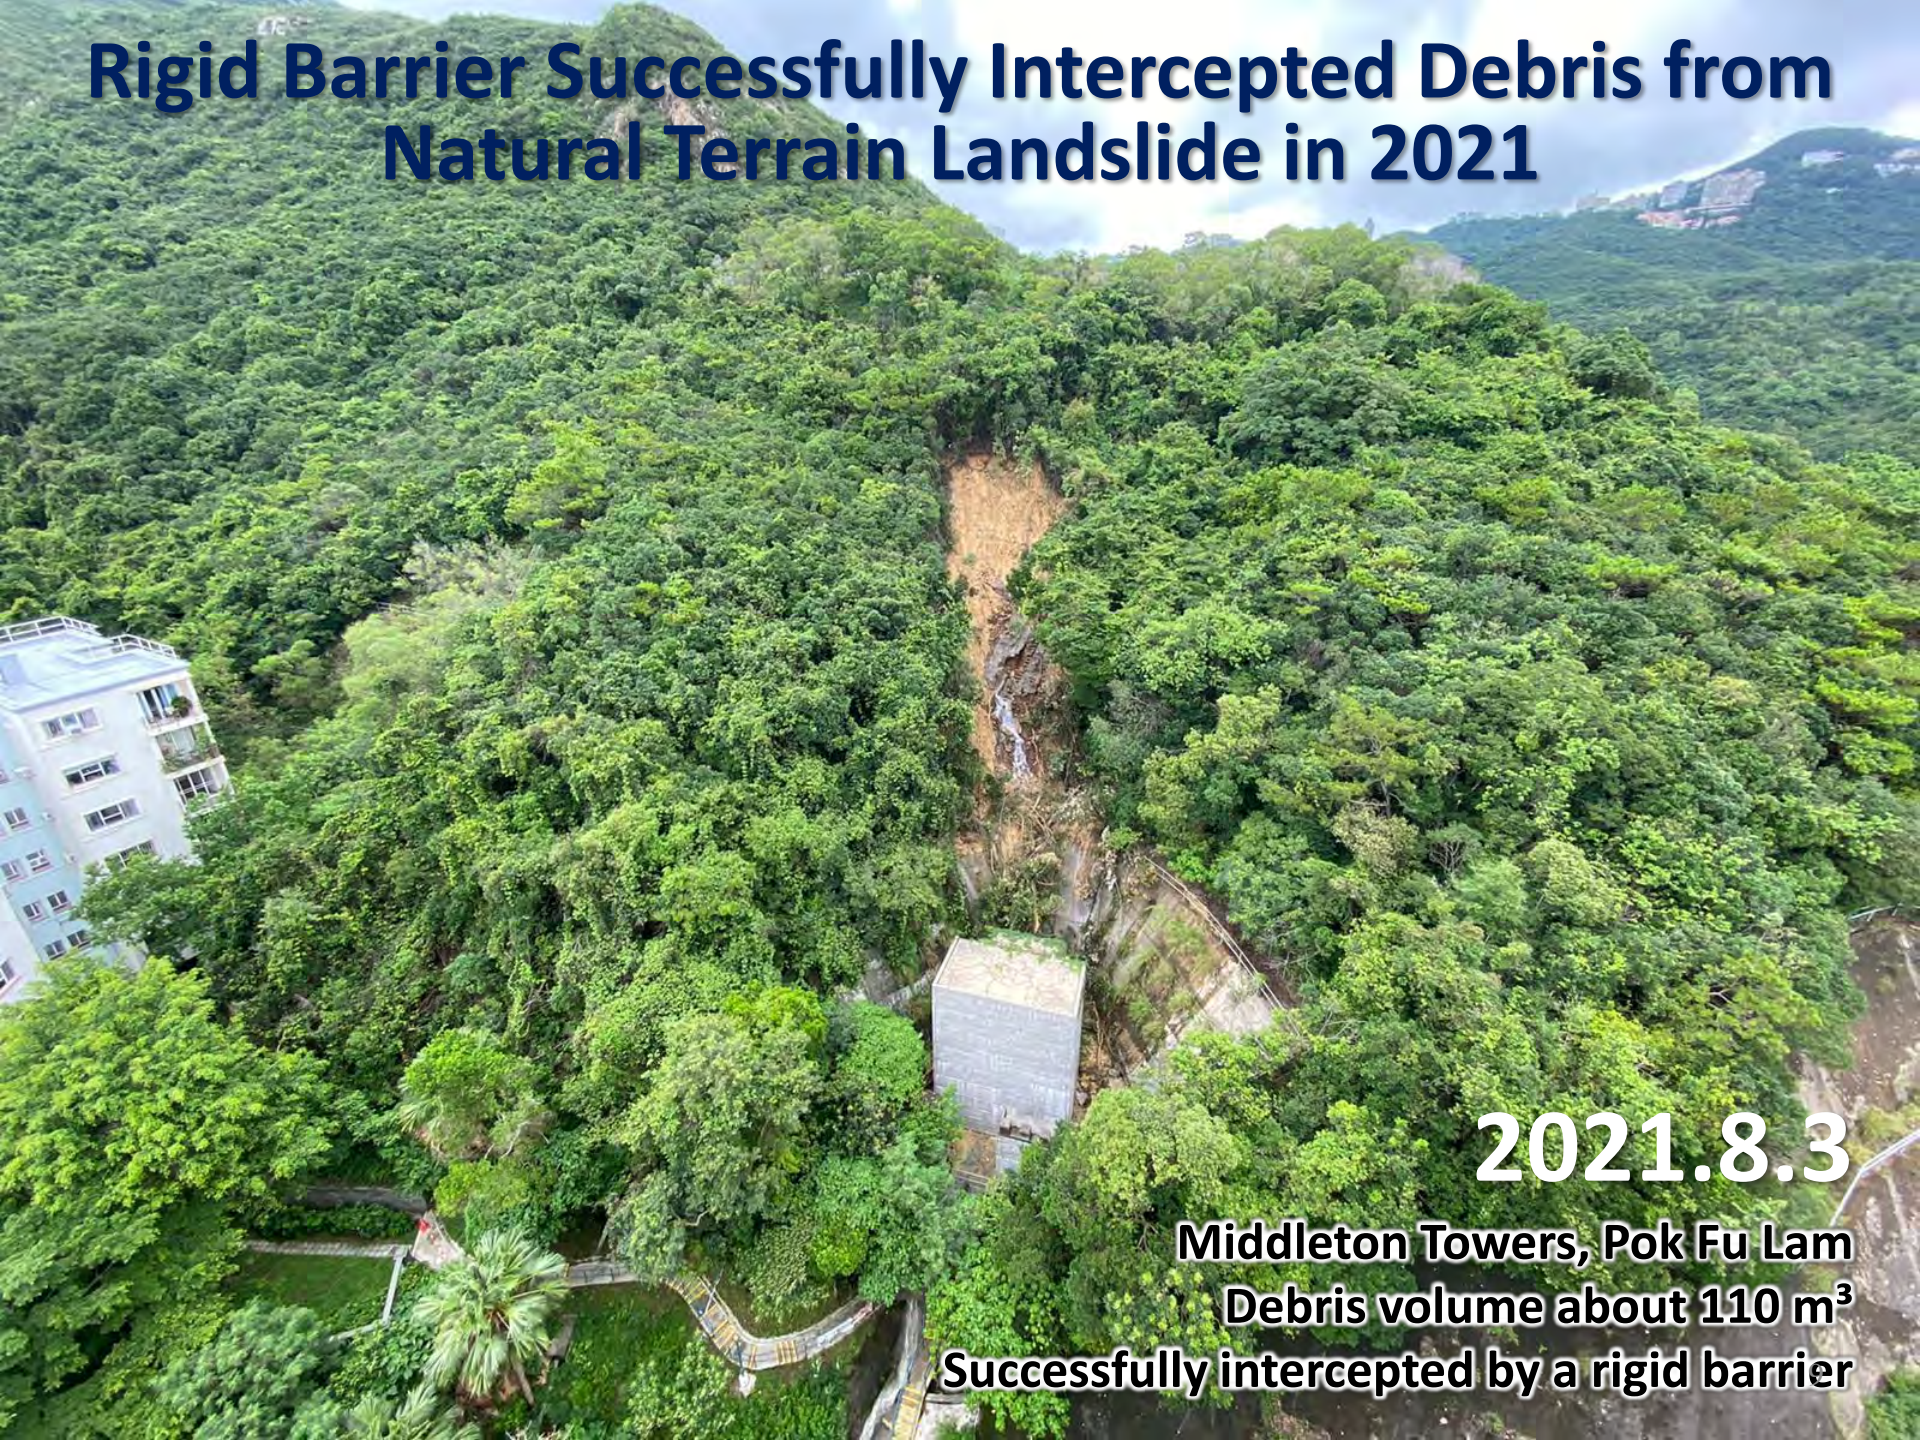
Rigid Barrier Successfully Intercepted Debris from Natural Terrain Landslide in 2021

2021.8.3

Middleton Towers, Pok Fu Lam

Debris volume about 110 m³

Successfully intercepted by a rigid barrier

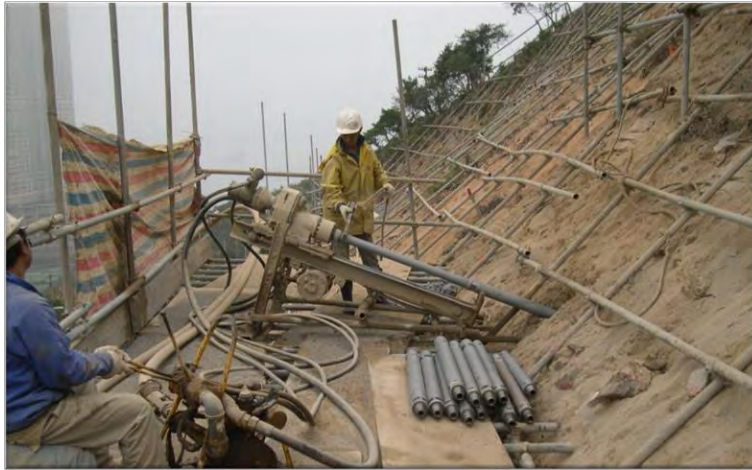
Use of soil nails to enhance the robustness of slope

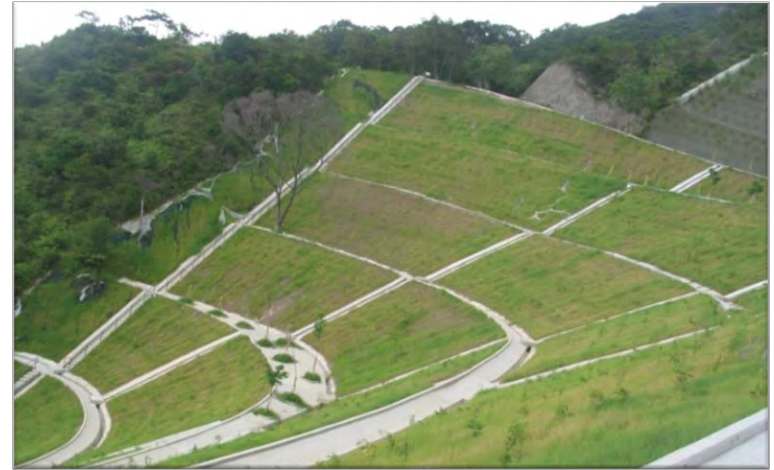
Enhancement of slope drainage capability

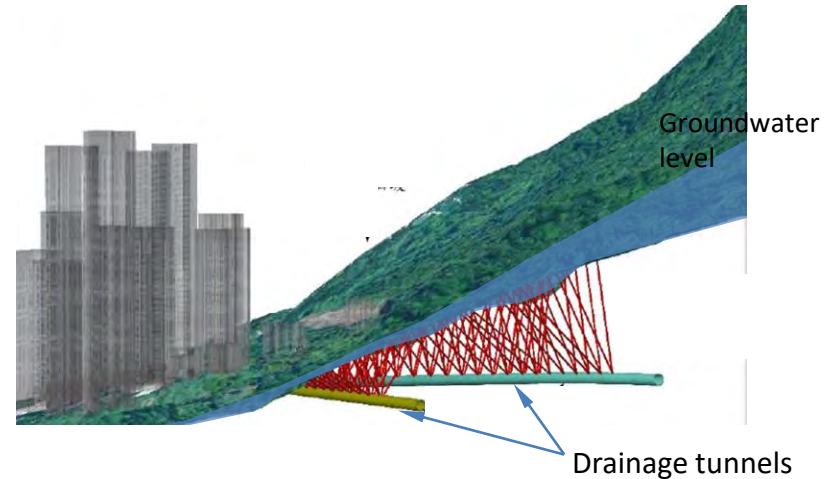
Use of drainage tunnel to regulate regional groundwater

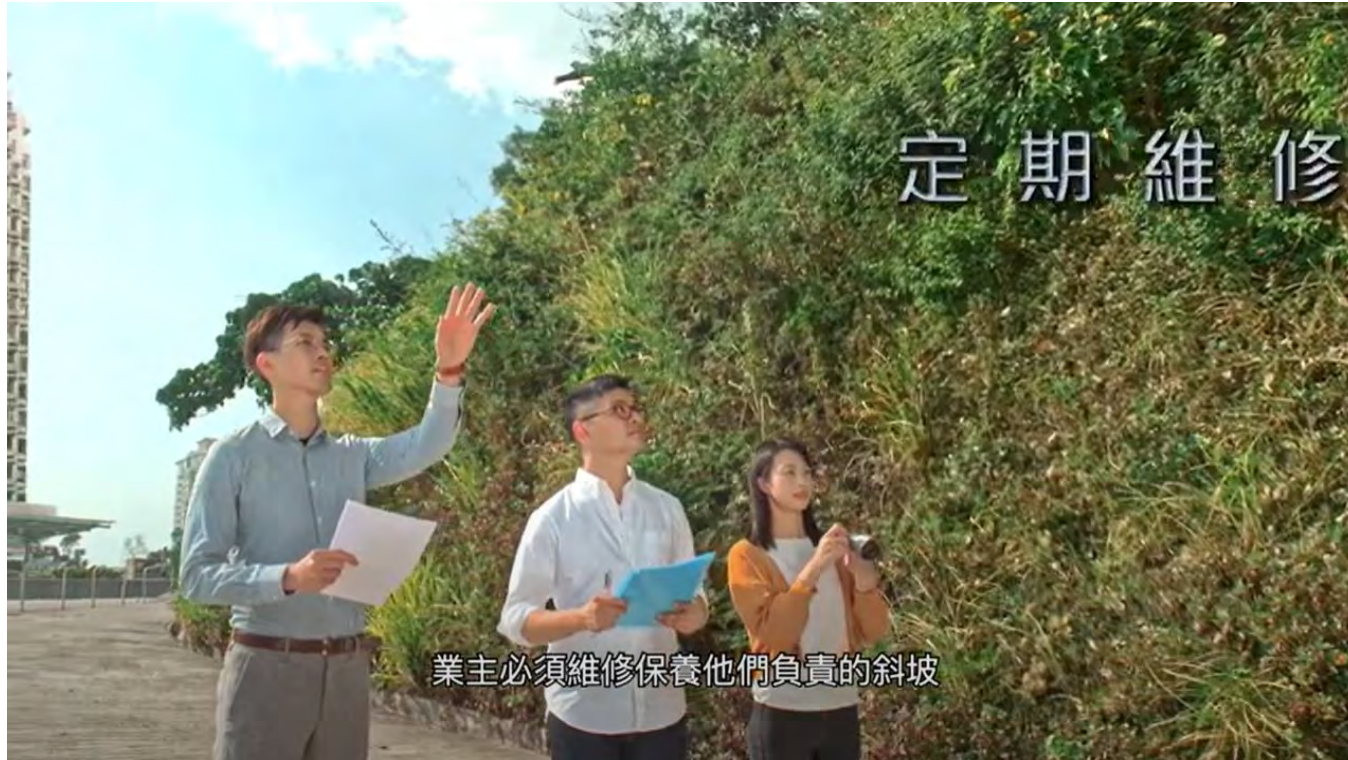
Regular Slope Maintenance

Routine Maintenance Inspection

- ◆ at least once every year
- ◆ complete all slope inspection and maintenance prior to onset of wet season
- ◆ inspect the drainage channels and clear any blockage after a heavy rainstorm

Engineer Inspections for Maintenance

- ◆ once every 5 years
- ◆ by a professionally-qualified geotechnical engineer
- ◆ geotechnical engineer to provide advice on slope maintenance and improvement works

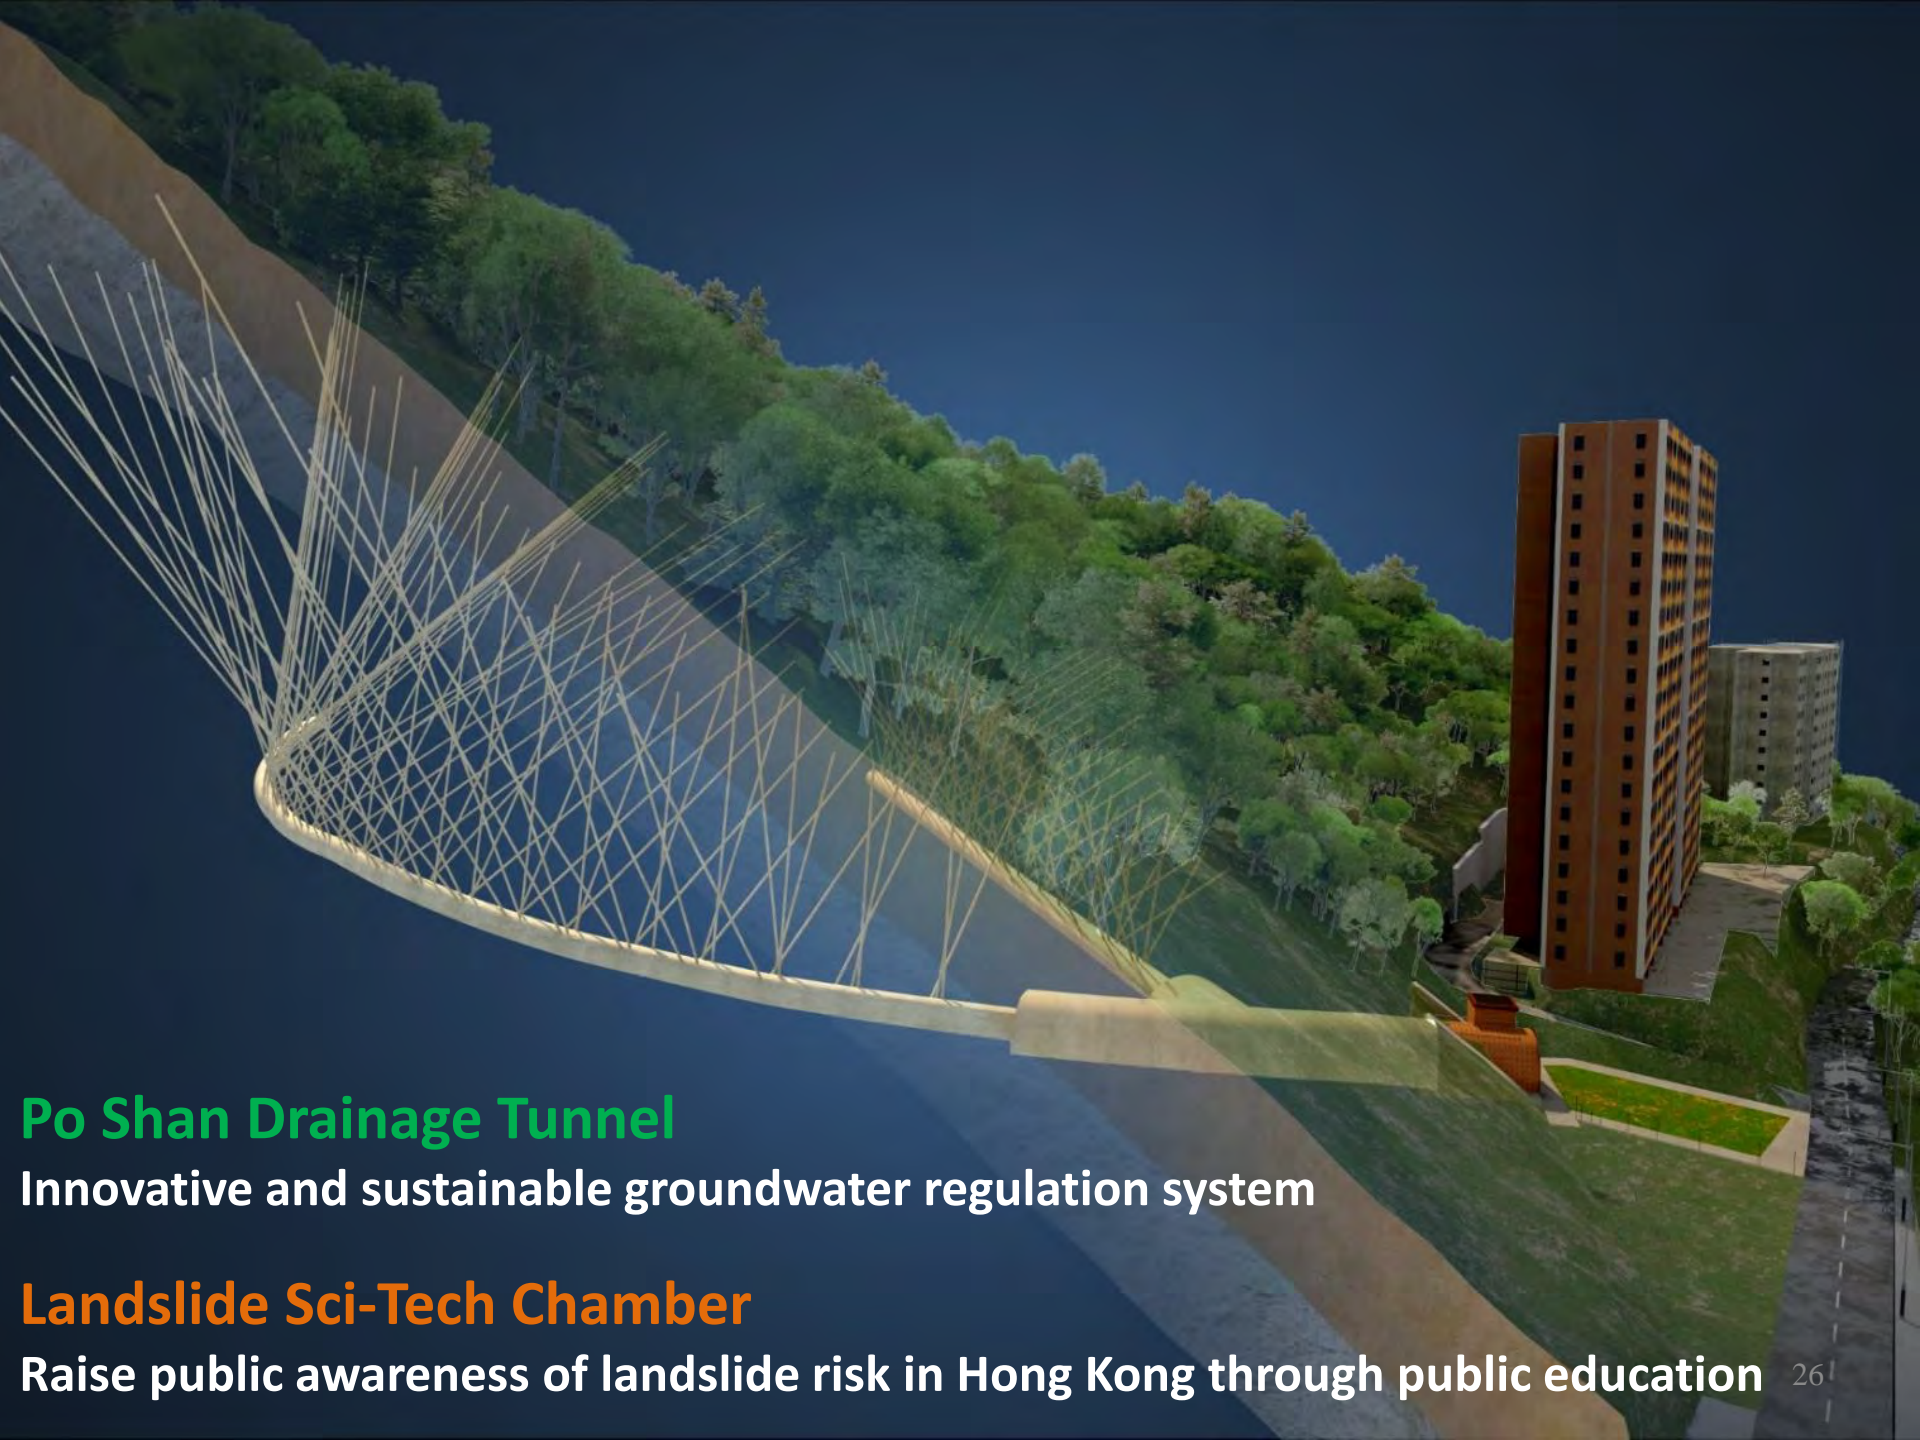
Po Shan Drainage Tunnel

Innovative and sustainable groundwater regulation system
