新界西堆填區附近溪流的水質指數評級 (2003-2023年)

Water Quality Index Rating of Streams near the WENT Landfill (2003-2023)

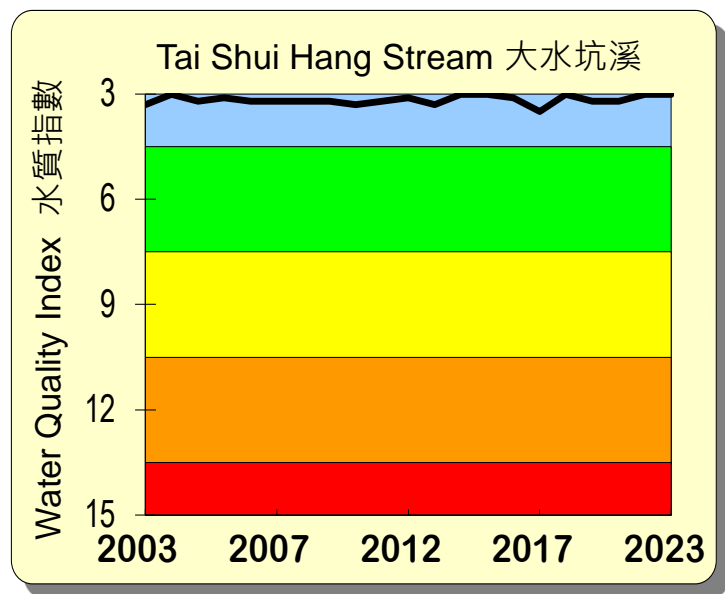
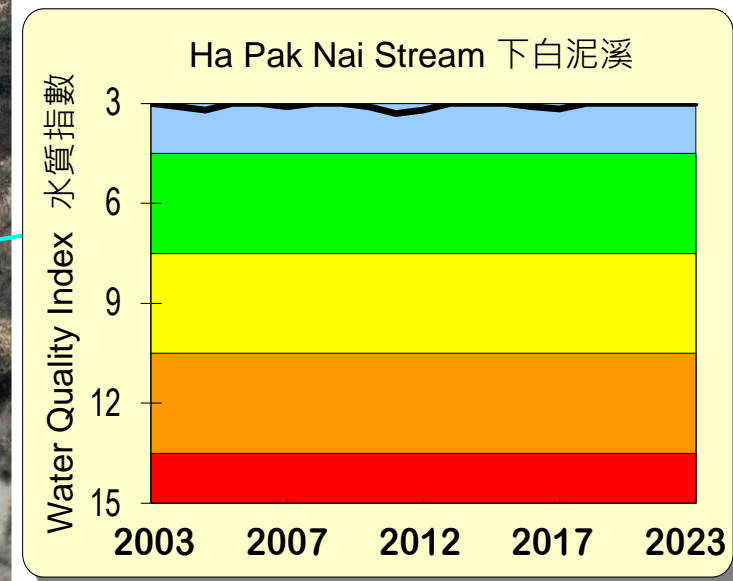
水質指數 全年平均水質指數 (■ 極佳 ■ 良好 ■ 普通 ■ 惡劣 ■ 極劣)

WQI Annual Water Quality Index (■ Excellent ■ Good ■ Fair ■ Bad ■ Very Bad)

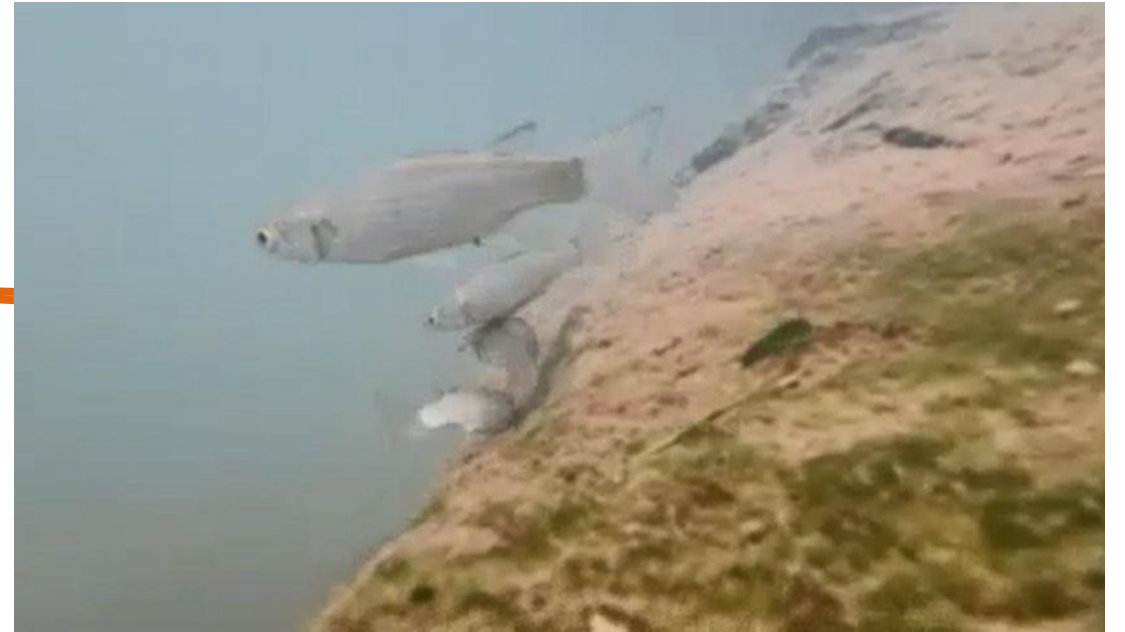
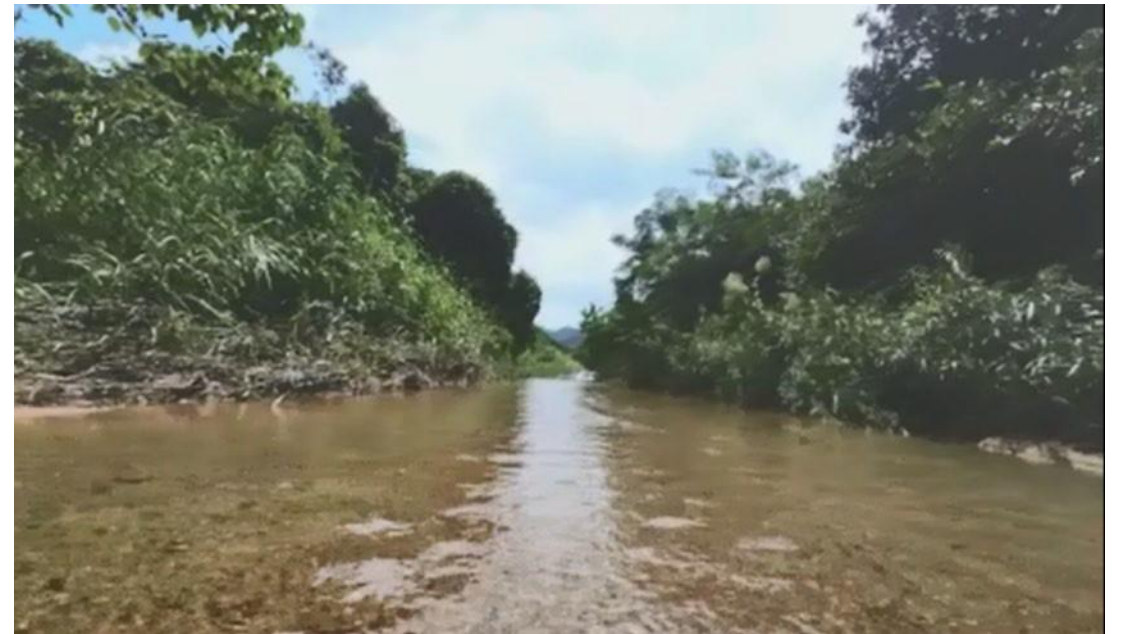
環保署抽取水樣及沉積物樣本以檢測二噁英水平 (2023年9月及10月)

EPD's Sampling of Water and Sediment Samples for Testing of Dioxins (Sep and Oct 2023)

- 環保署分別於2023年9月及10月在大水坑溪及涉事大閘蟹養殖場附近的河道採集水及沉積物樣本，進行二噁英測試。EPD collected water and sediment samples at Tai Shui Hang Stream adjacent to the concerned hairy crab farm in Sep and Oct 2023, respectively for testing of dioxins.
- 所有水樣本均沒有驗出二噁英類化學物，底泥樣本中二噁英及二噁英類多氯聯苯的水平也極低，與正常環境背景水平相若。No dioxins chemicals were detected in the water samples, and the levels of dioxins and dioxin-like polychlorinated biphenyls (DL-PCBs) in the sediment samples were also very low, similar to normal environmental background levels.
- 分析證實大閘蟹組織樣本及大水坑溪底泥樣本中的二噁英化學物成分截然不同，顯示大閘蟹的二噁英並非受附近環境或堆填區所致。Analysis confirmed that the compositions of dioxins and DL-PCBs in hairy crab tissue samples were significantly different, indicating that the dioxins found in hairy crabs were not related to the nearby environment or landfills.
