Task Force on Excessive Lead in Drinking Water

25 September 2015

Preliminary report

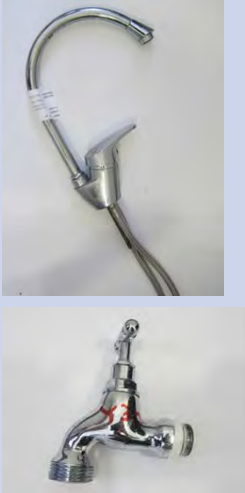
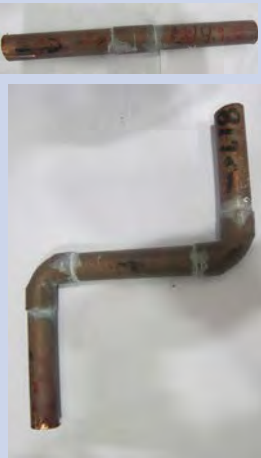
Number of components from three water chains dismantled for examination/testing

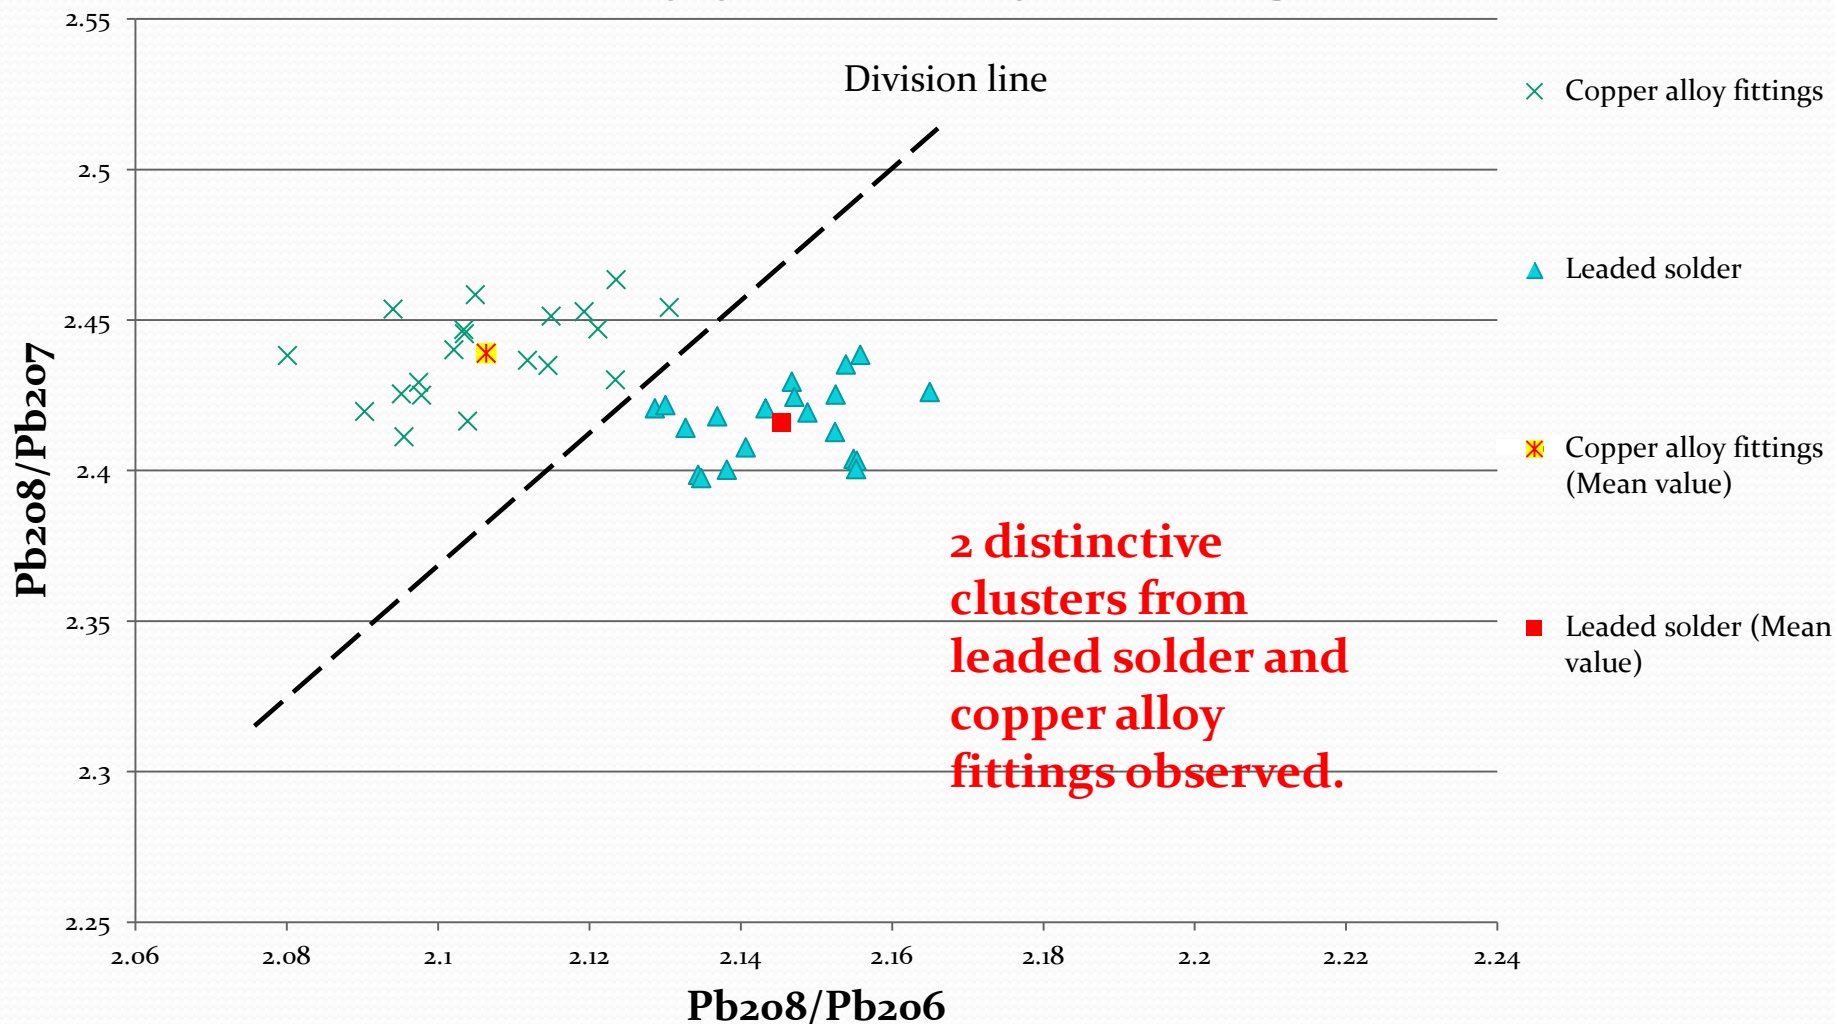
Isotopic analysis of leaded solder and copper alloy fittings

- Lead contains three main isotopes – ^{206}Pb : ^{207}Pb : ^{208}Pb .
- Lead from different origins has different isotopic ratios (like fingerprint)
- Precision instrument can measure the distribution of different isotopic ratios, thus locating the source of lead in water
- By working out the ratios of lead isotopes in leaded solder, copper alloy fittings and water samples with excessive lead content (fingerprints), we can find out the main source of lead in water

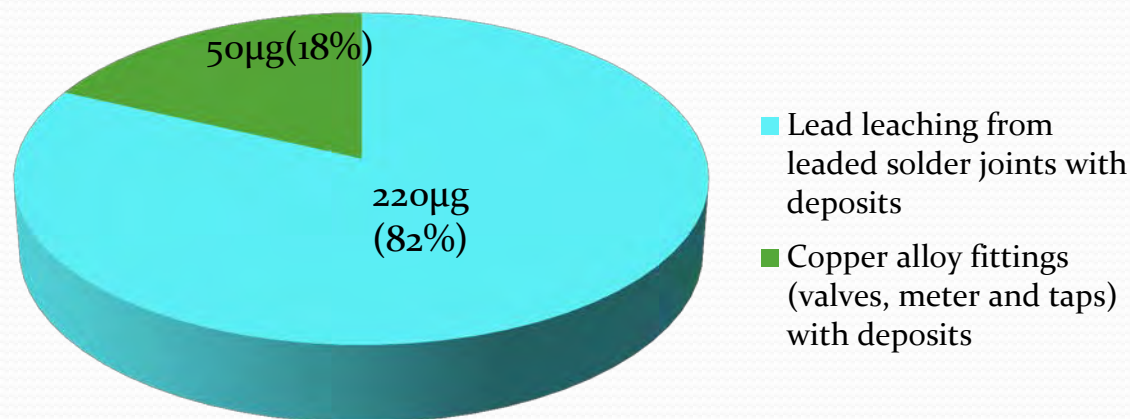
- Calculate the total lead amount leached and the contribution from all pipe components by using the 24-hour leaching test results (see diagram below).
- Assuming only copper alloy fittings leach lead, calculated lead leaching: **2.7 $\mu\text{g/L}$** , below WHO standard of 10 $\mu\text{g/L}$. Lead leached from copper alloy fittings does not result in excessive lead in drinking water.
- Mathematic modeling confirms that excessive lead in drinking water in Kai Ching Estate and Kwai Luen Estate Phase II is caused by leaded solder joints.

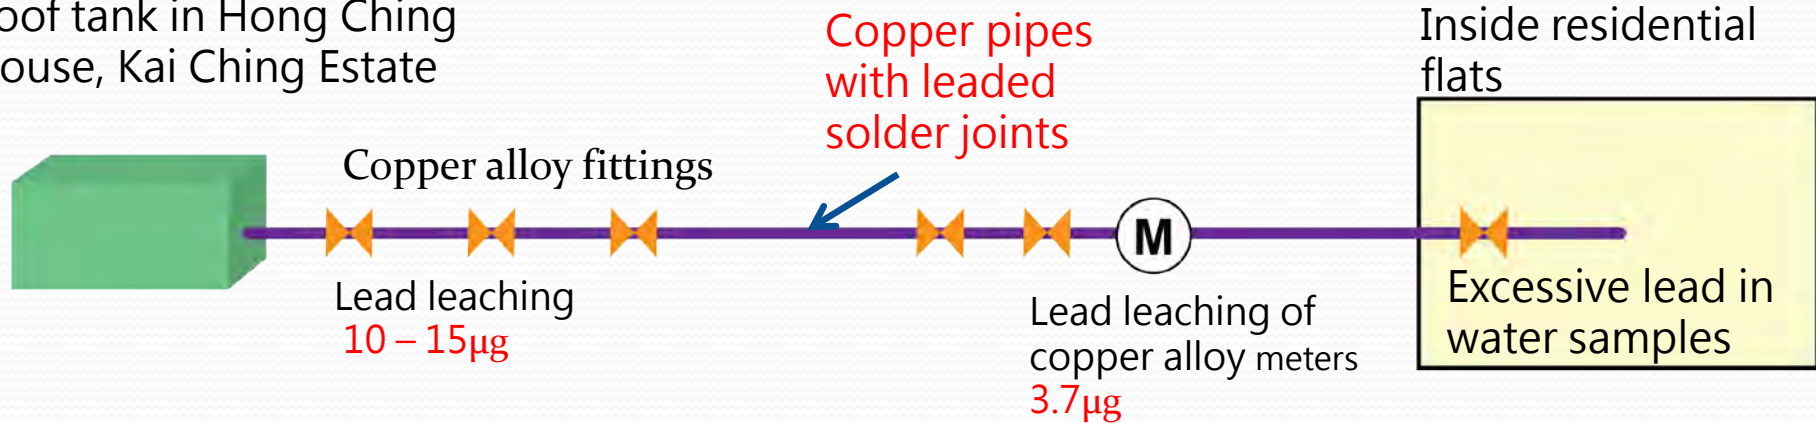
Roof tank in Hong Ching House, Kai Ching Estate

The test results of Hong Ching House and Hung Hei House confirm that even though the copper alloy fittings leach lead, they do not result in excessive lead in water
