Design of Entrance/Exit B of South Horizons Station

海怡半島站B出入口與涉事食水管位置的示意圖

Indicative diagram showing the positions of Entrance/Exit B of South Horizons Station and the concerned fresh waterpipe

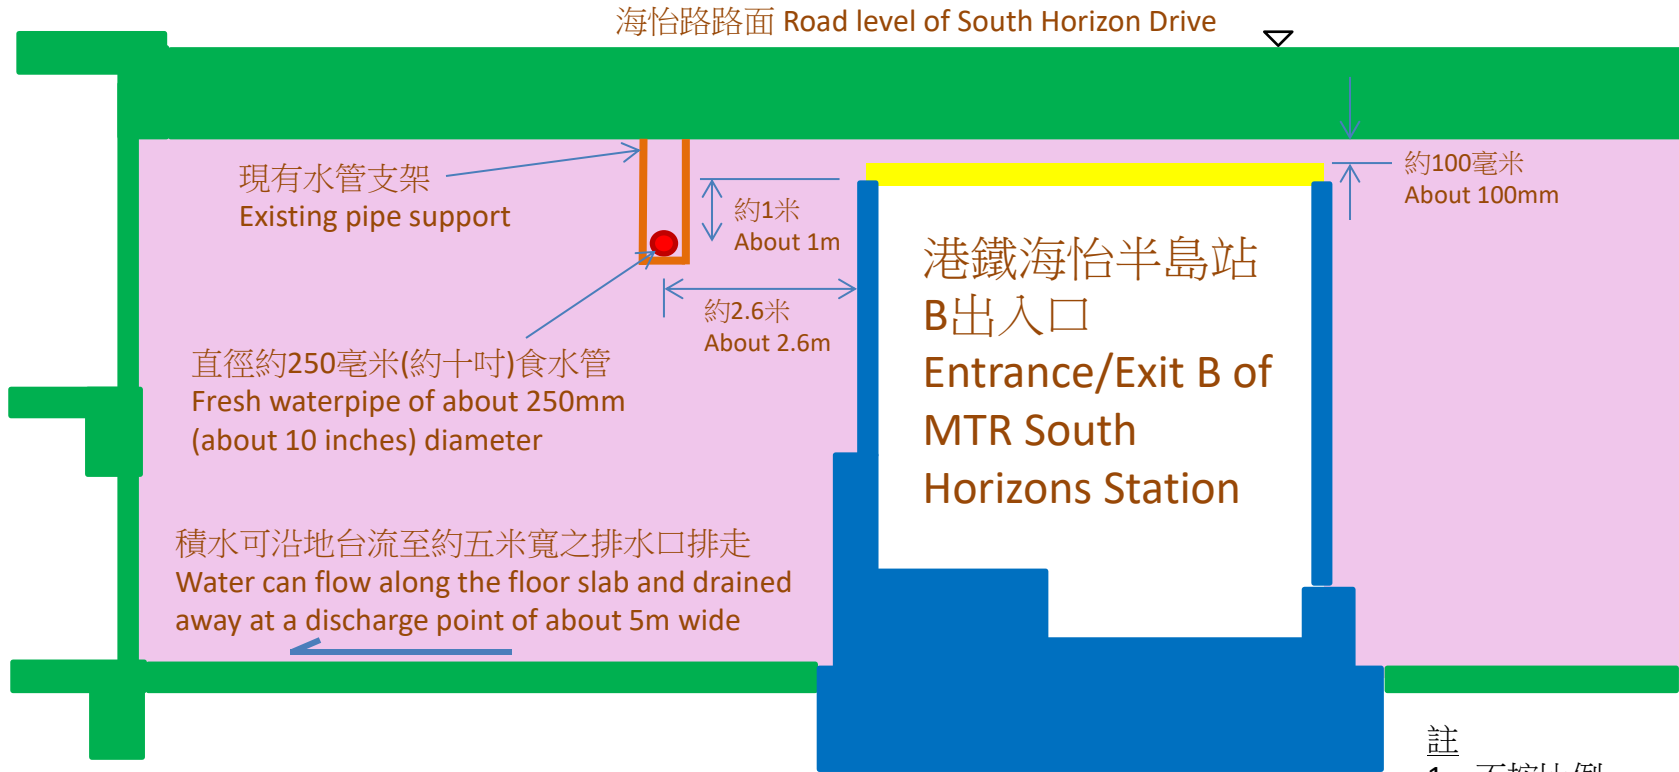
In the incident, part of the fire resistance board of the roof was damaged by the fresh water ejected from the water pipe. The fresh water then flowed into the concourse from the damaged part.

(以切面圖展示 Shown in Sectional View)

In general, MTR underground stations buried in soil or rock are constructed using concrete structure and with waterproof layer to prevent ingress of water into stations. Nevertheless, as Entrance/Exit B is protected by the structure of the existing underground void and restricted by the space of that void, its design is rather special, and fire resistance boards are used for constructing its roof. According to the clarification by the MTRCL, the portion of the Entrance/Exit B of South Horizons Station, which is adjacent to the concourse, was located within a void surrounded by concrete structure for placing underground utilities underneath the road level of South Horizon Drive. (Indicative diagram showing the positions of Entrance/Exit B of South Horizons Station and the fresh waterpipe concerned at **Appendix**) That concrete structure (coloured in green at **Appendix**) is owned by the South Horizon. As that void (coloured in pink at **Appendix**) is completely isolated, it would not be affected by underground water or rain. Hence, the roof of Entrance/Exit B (coloured in yellow at **Appendix**) could be constructed using thinner fire resistance board.
